FEASIBILITY ASSESSMENT REPORT

Old Library
707 East College Street

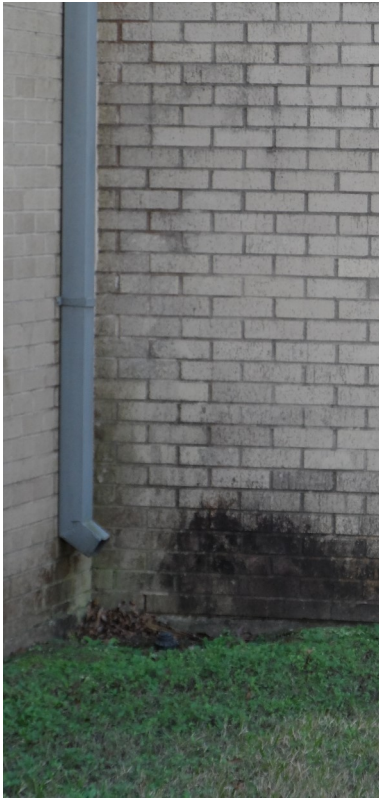
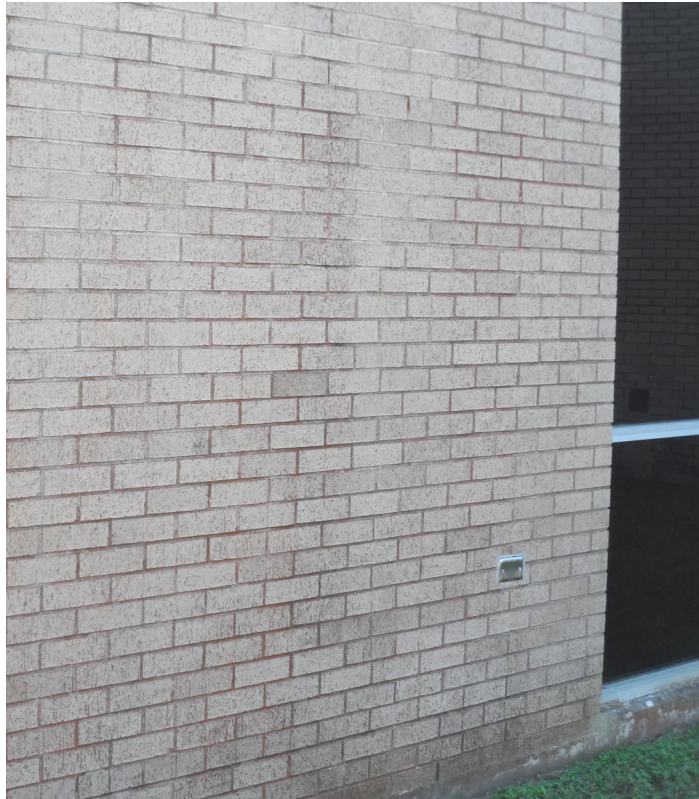
Brick and joints needs to be cleaned

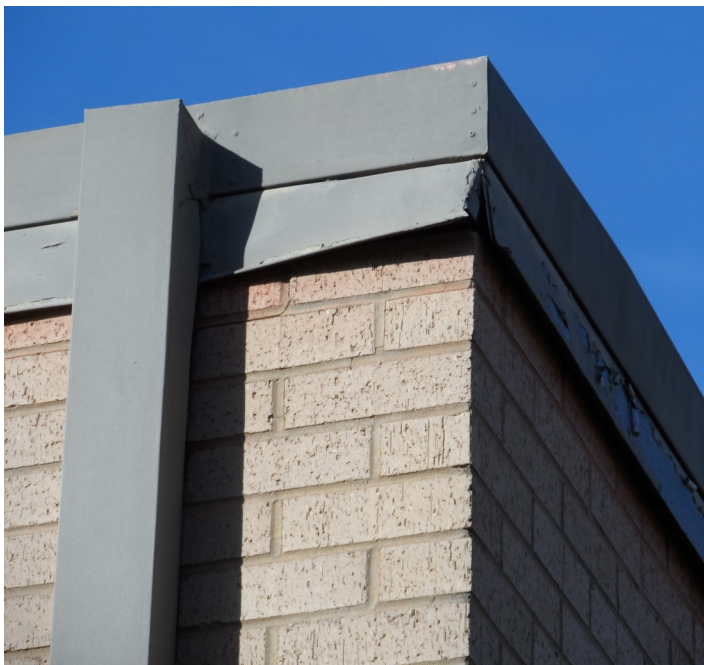
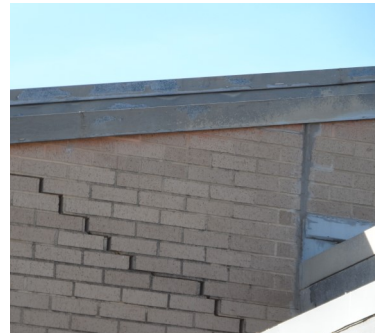
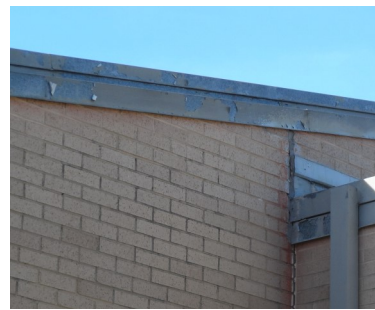
Fascia in poor condition on all sides of the building

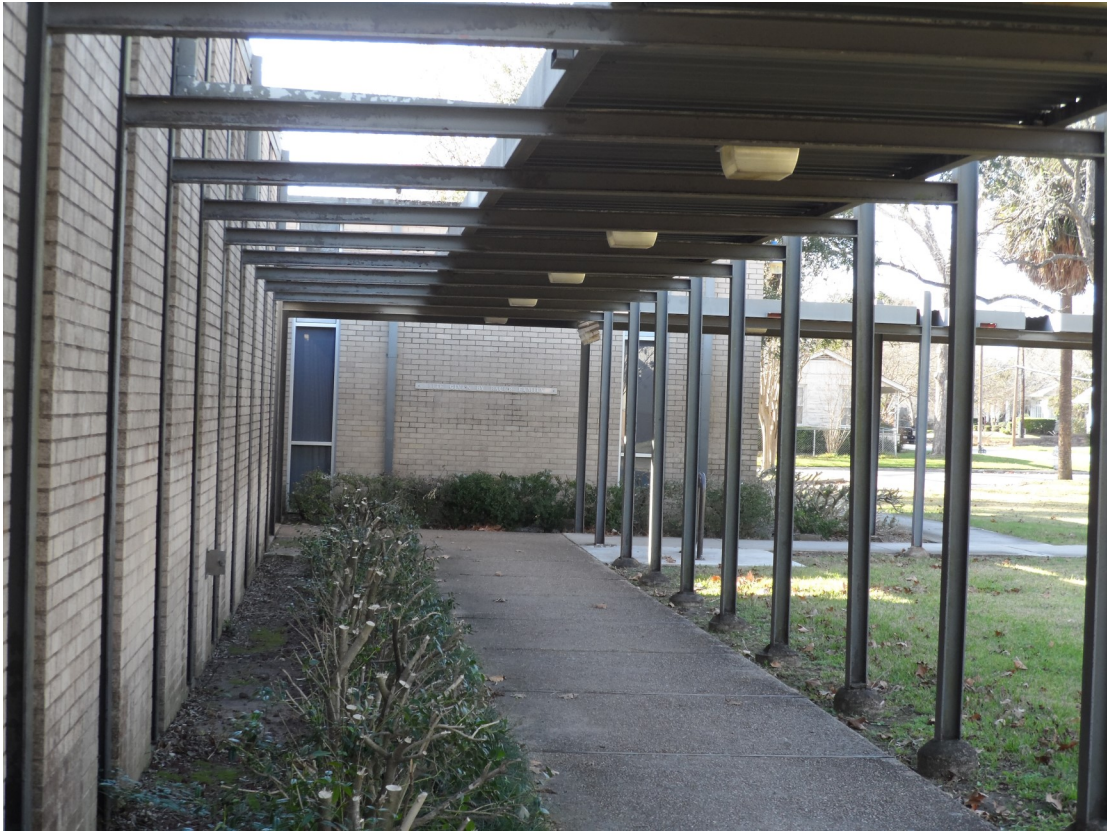
Paint on steel canopy is peeling

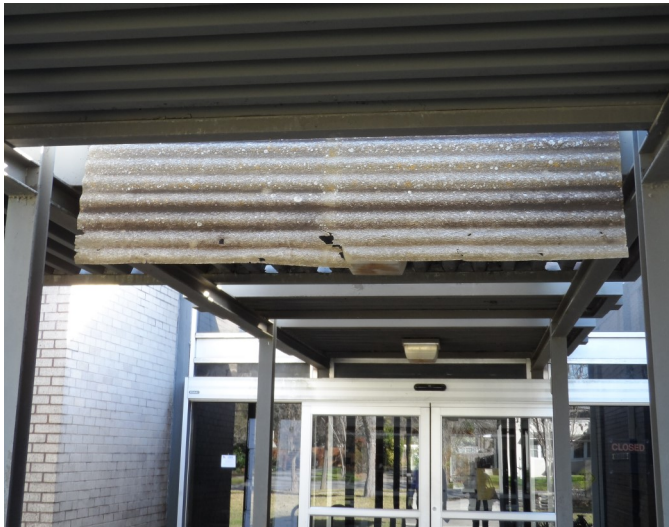
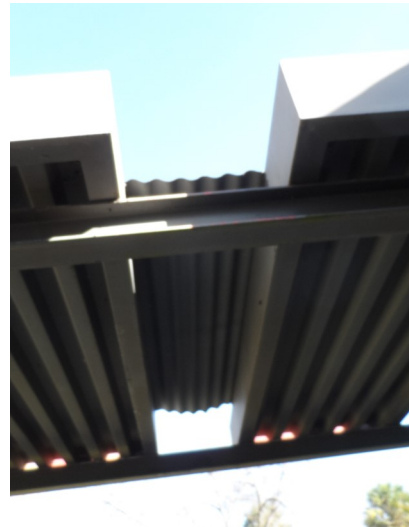
Corrugated metal panels added between framed bays recommended to be removed

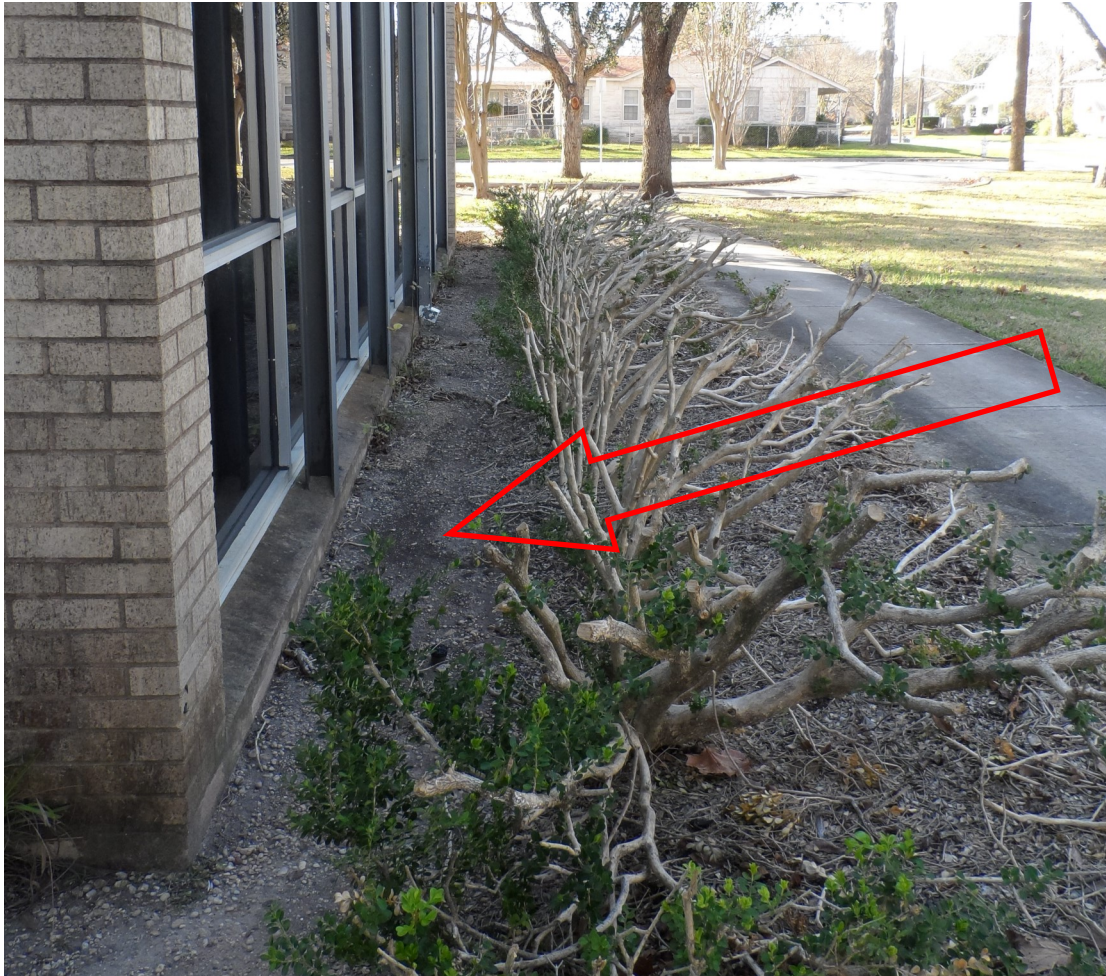
Drainage from East College Street slopes down toward the entrance of the Library

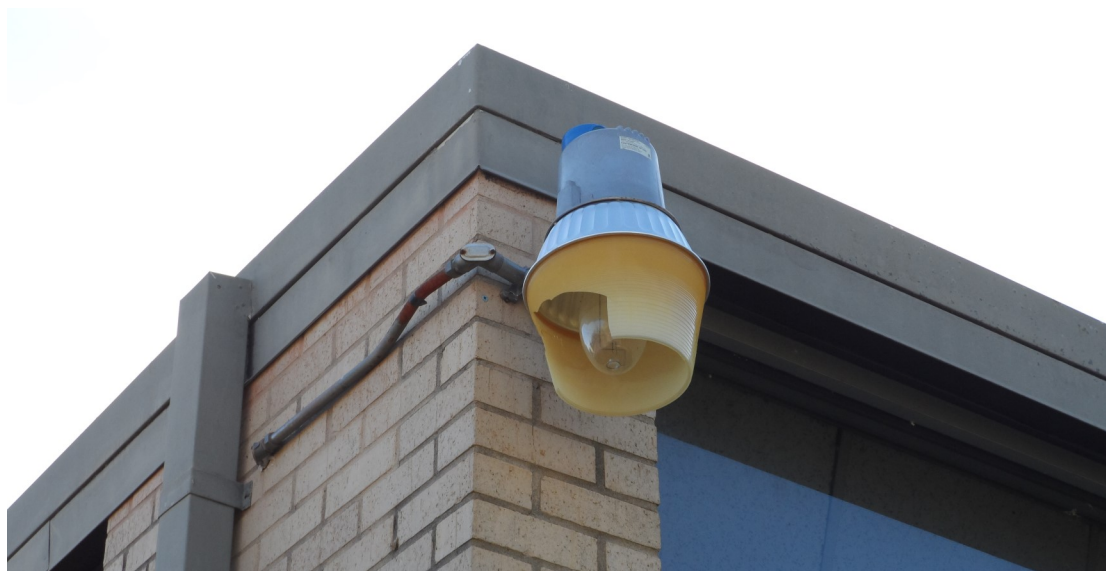
Broken and faded exterior light fixture

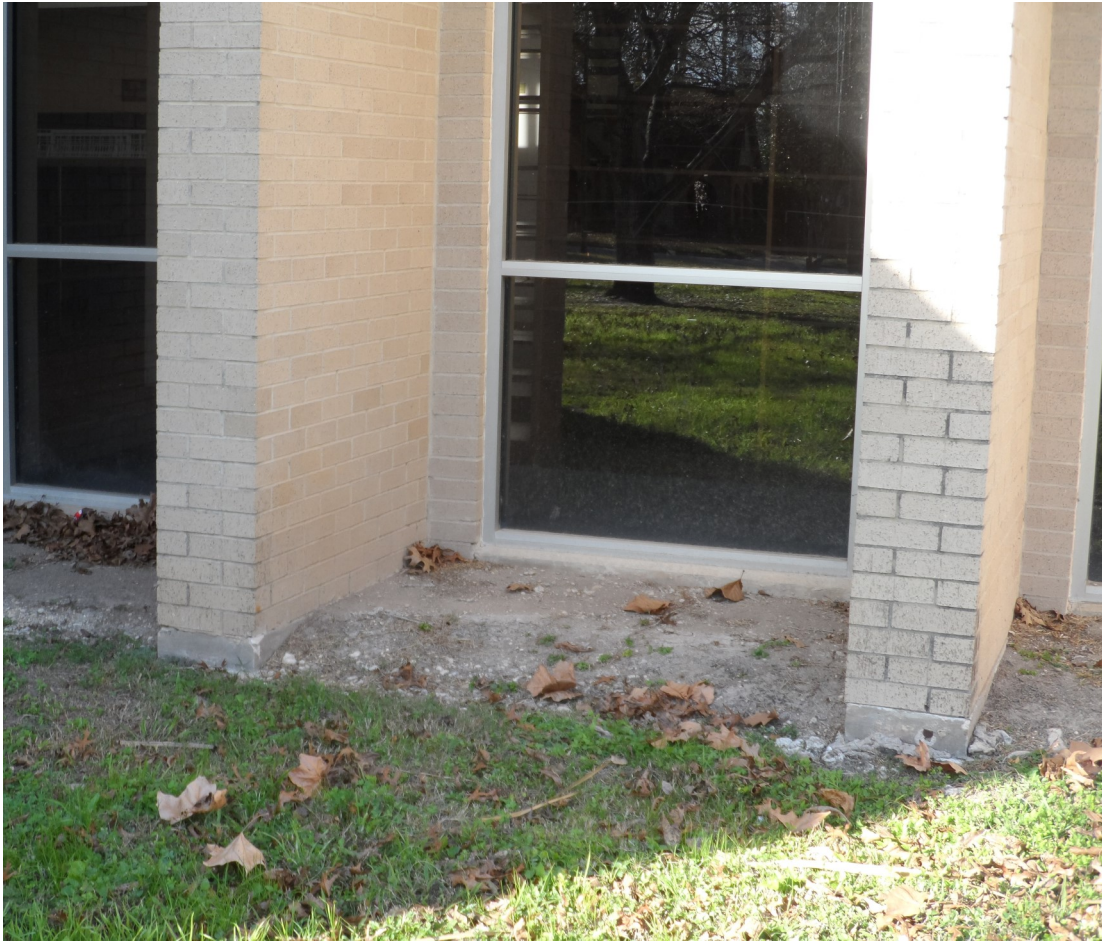
Exposed foundation at masonry fins on South façade eroding

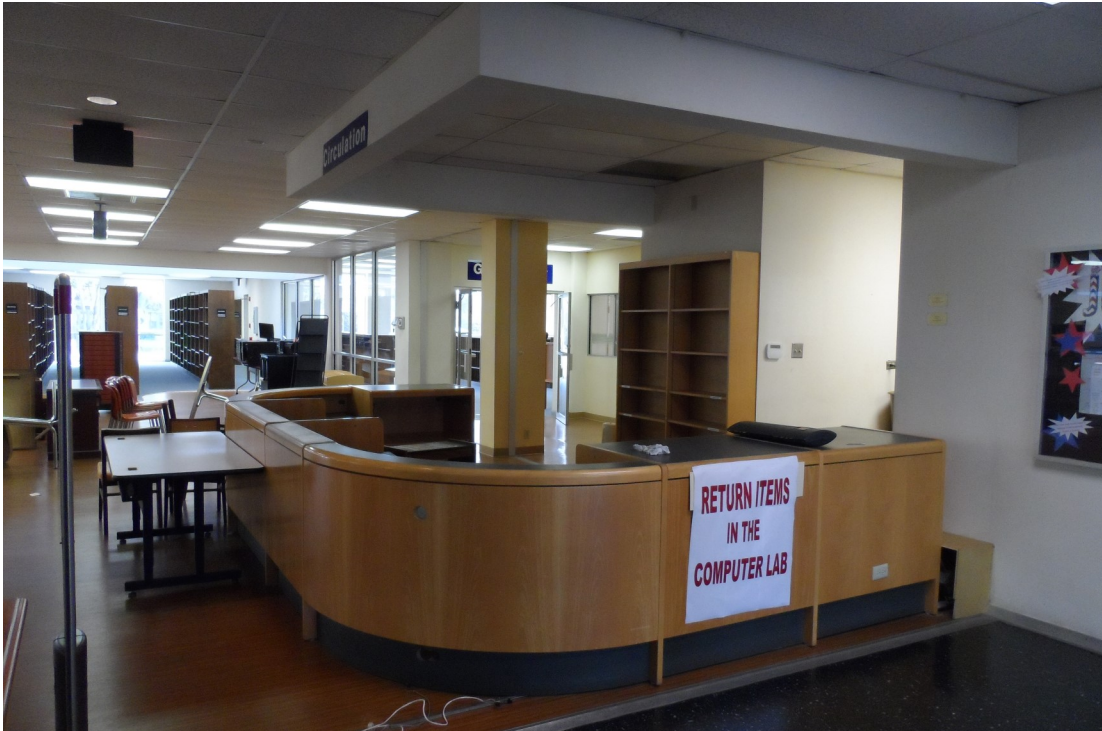
The original circulation desk and other furnishings are in good condition

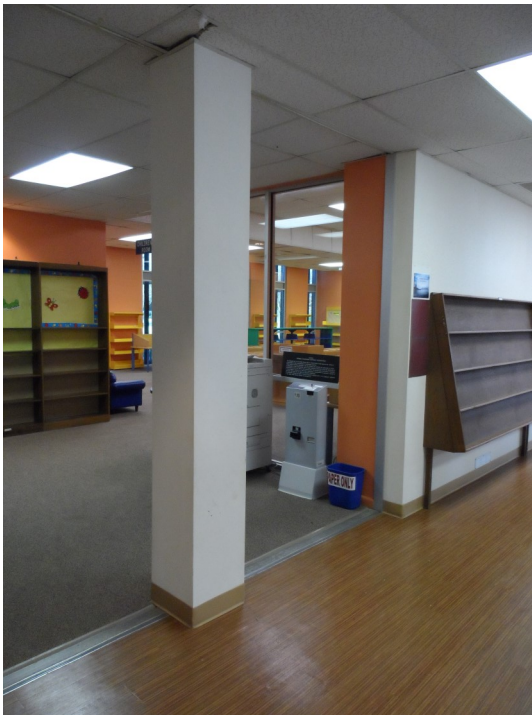
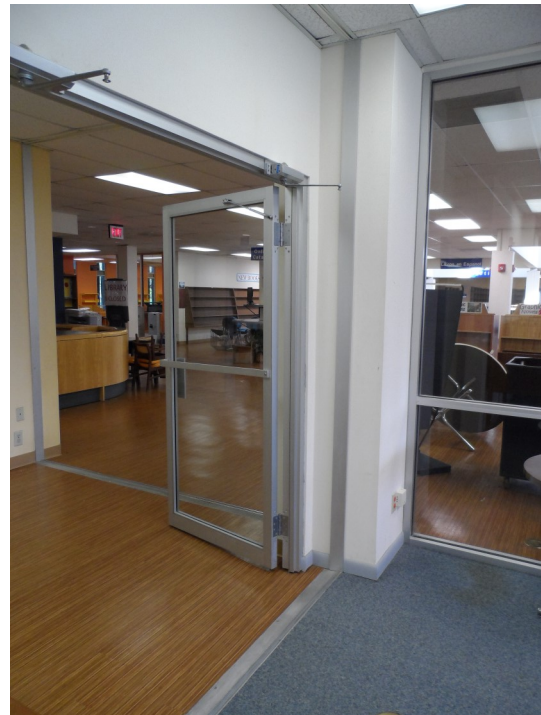
Expansion joints are visible between the original 1964 Library and the 1985 addition

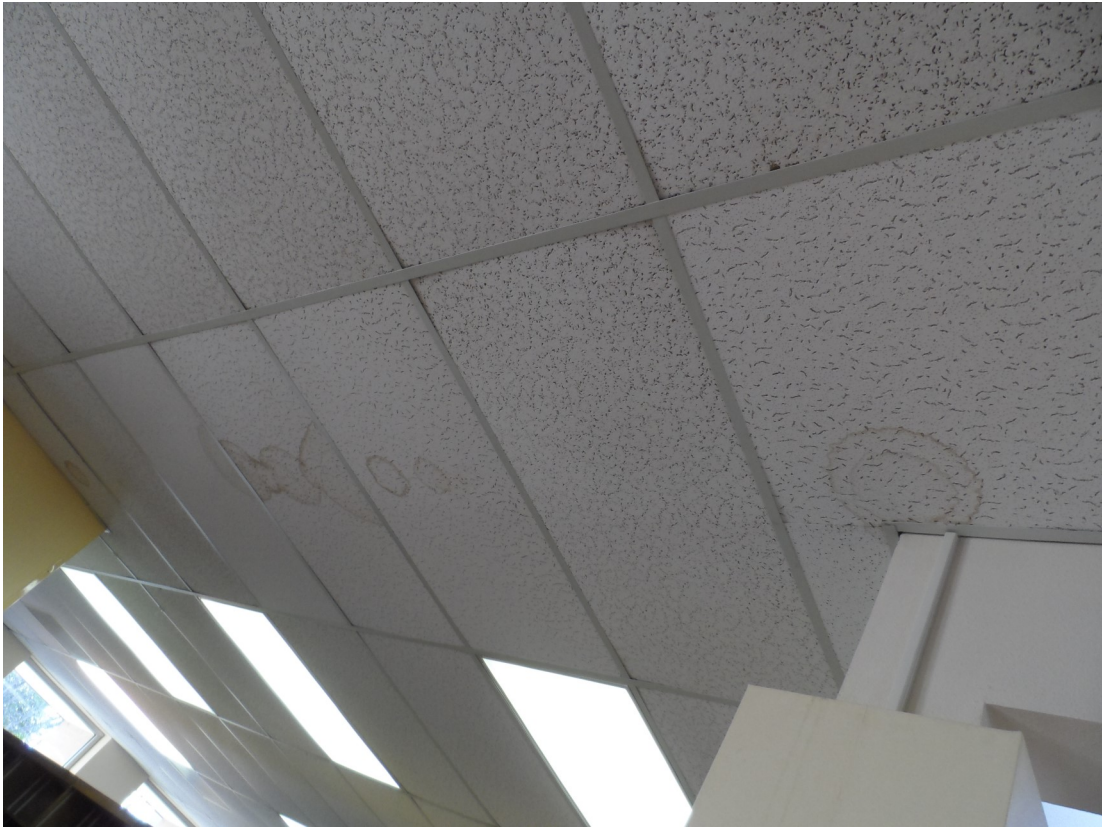
Some acoustical ceiling tiles are stained and many are dirty from age

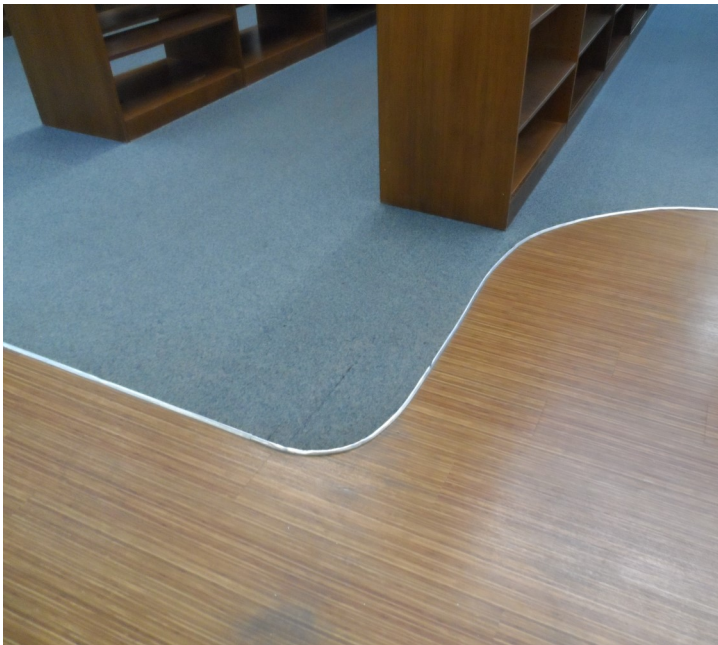
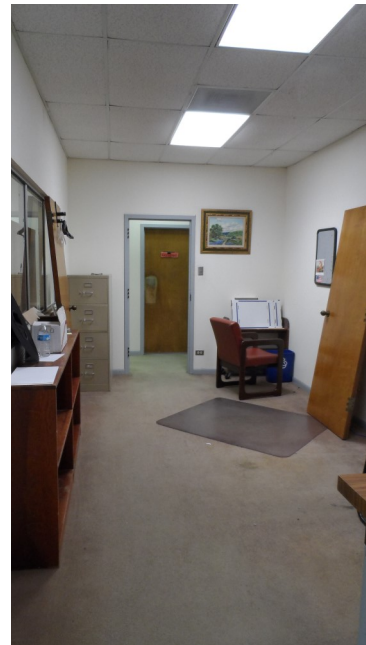
Carpet and vinyl flooring shows some wear and dirt, especially in support areas

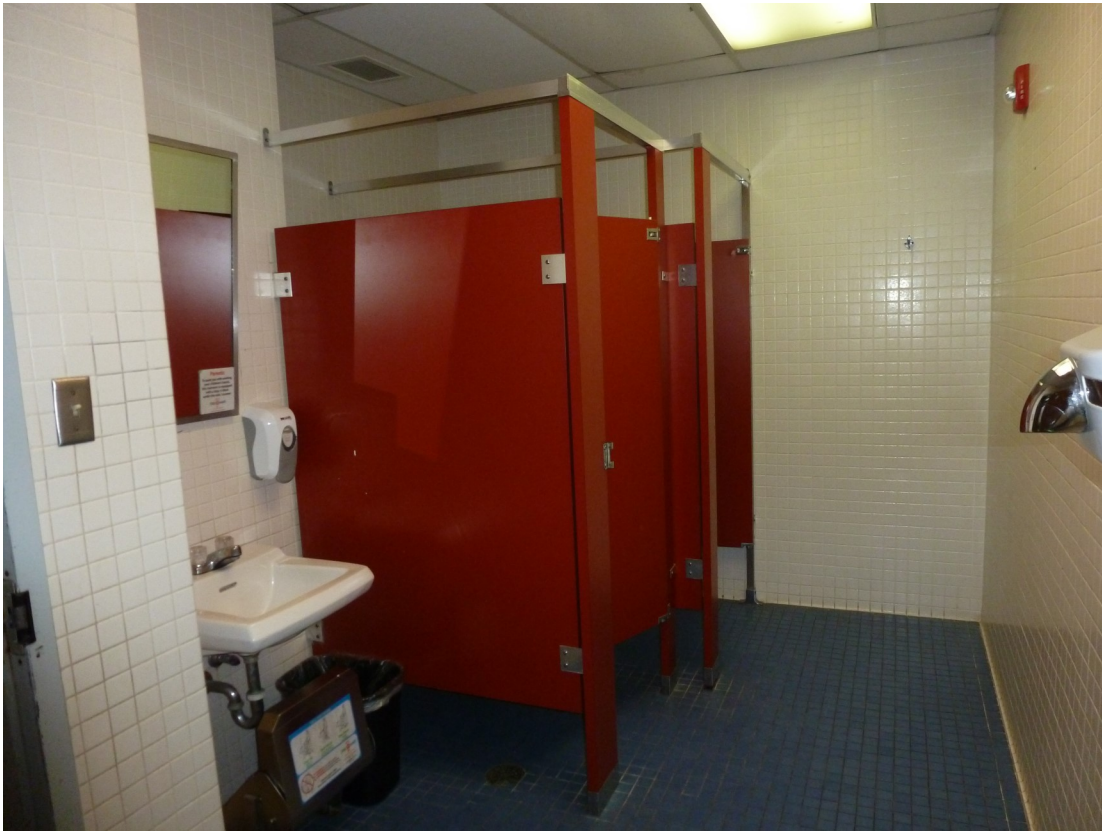
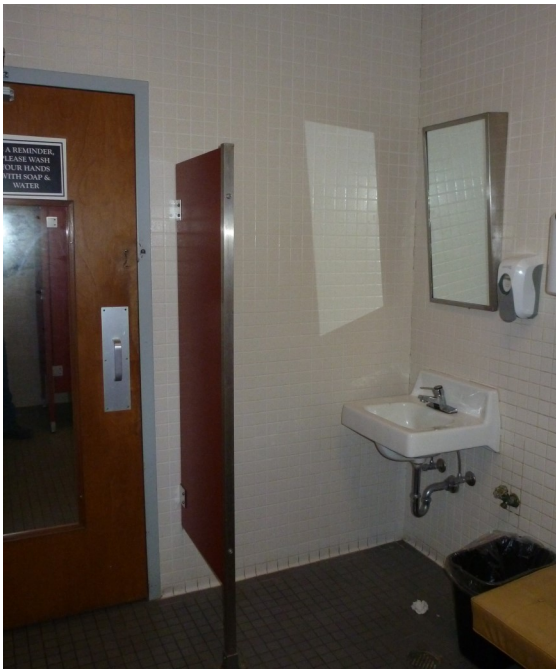
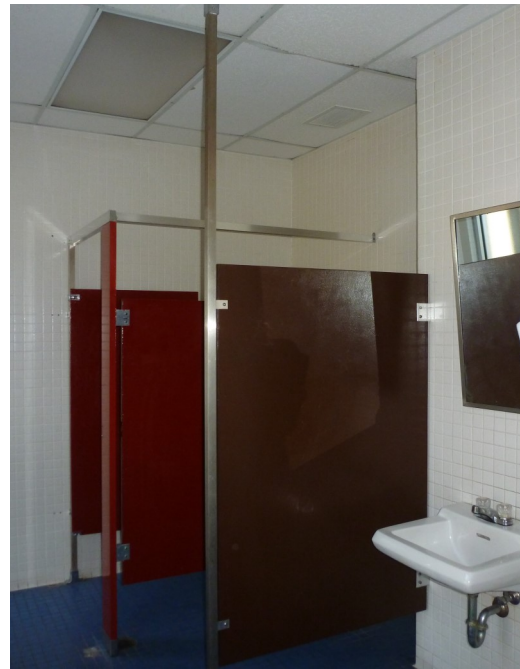
All restrooms will require a redesign in order to comply with accessible clearances

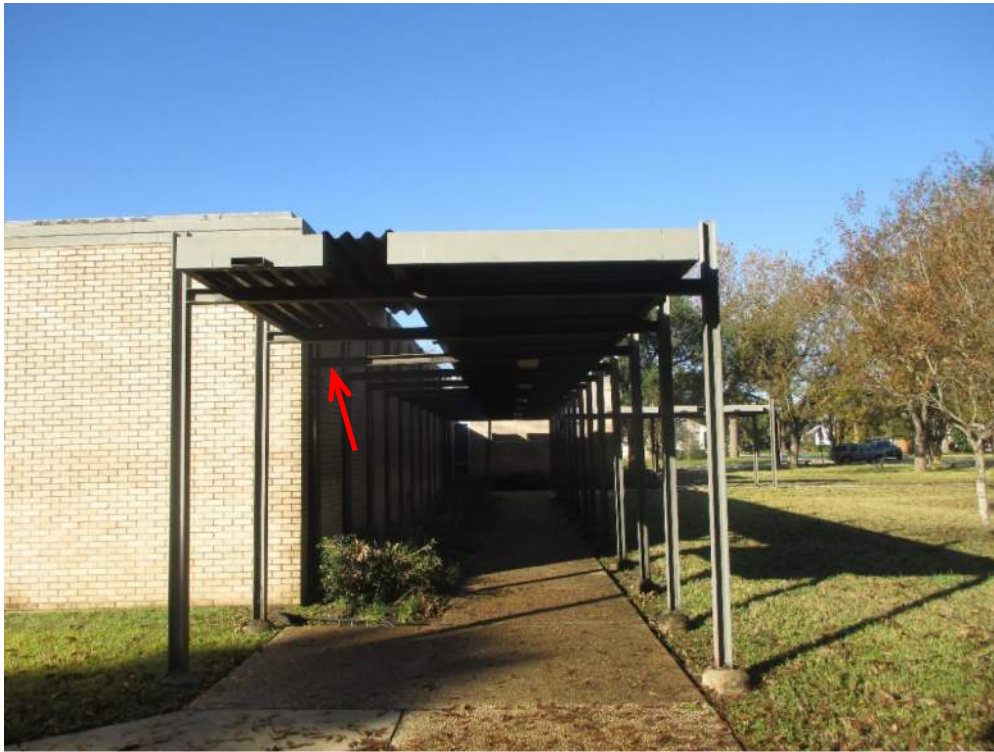
Photo 1: Steel canopy framing at the north (front) side of the building. Individual canopy columns supported by drilled footings were at a visibly different elevation compared to those at building foundation. The canopy roof beam (red arrow) is lower at building side of canopy.

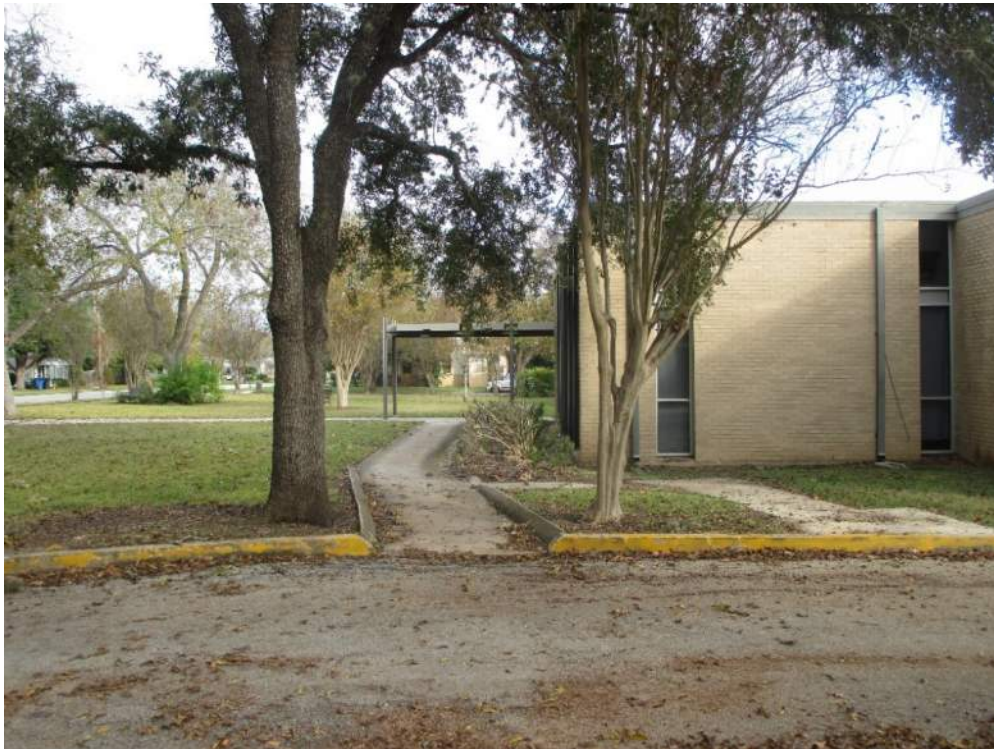
Photo 2: Exterior view looking east along the original front of the building showing potentially poor drainage in this area. The front canopy is visible in this photograph.

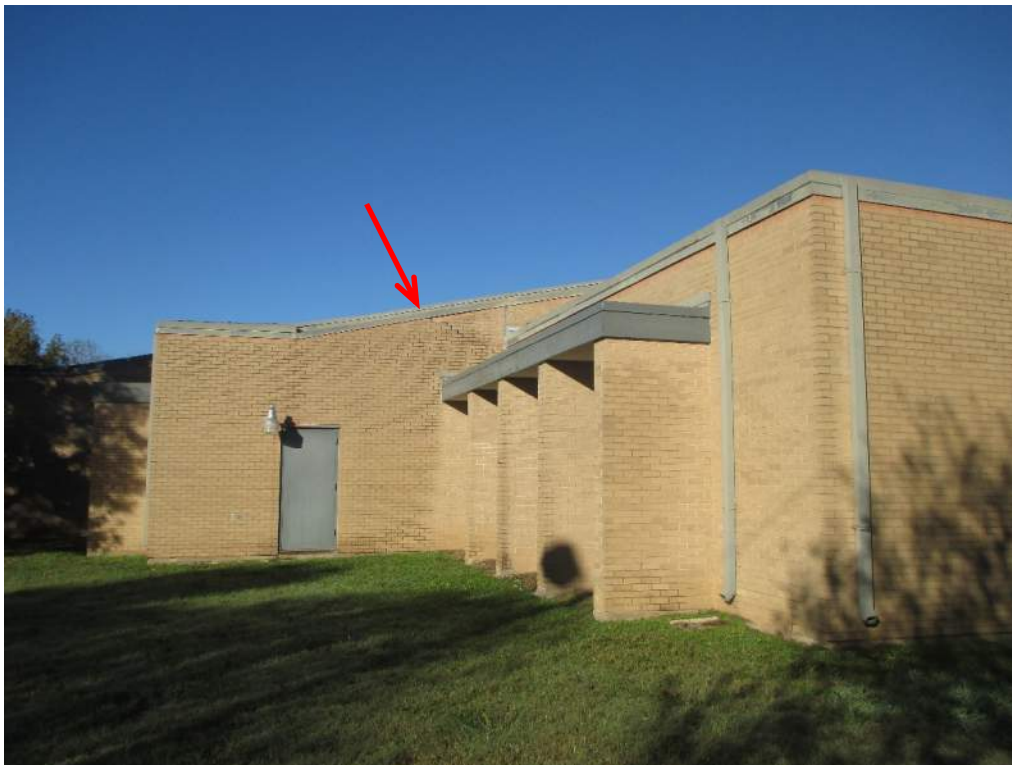
Photo 4: Southeast corner of the 1985 Addition where the exterior wall slopes up to match the sloping roof at the three clerestory skylights constructed in the Addition roof. Also, see Photo 5 for crack in brick at this location.

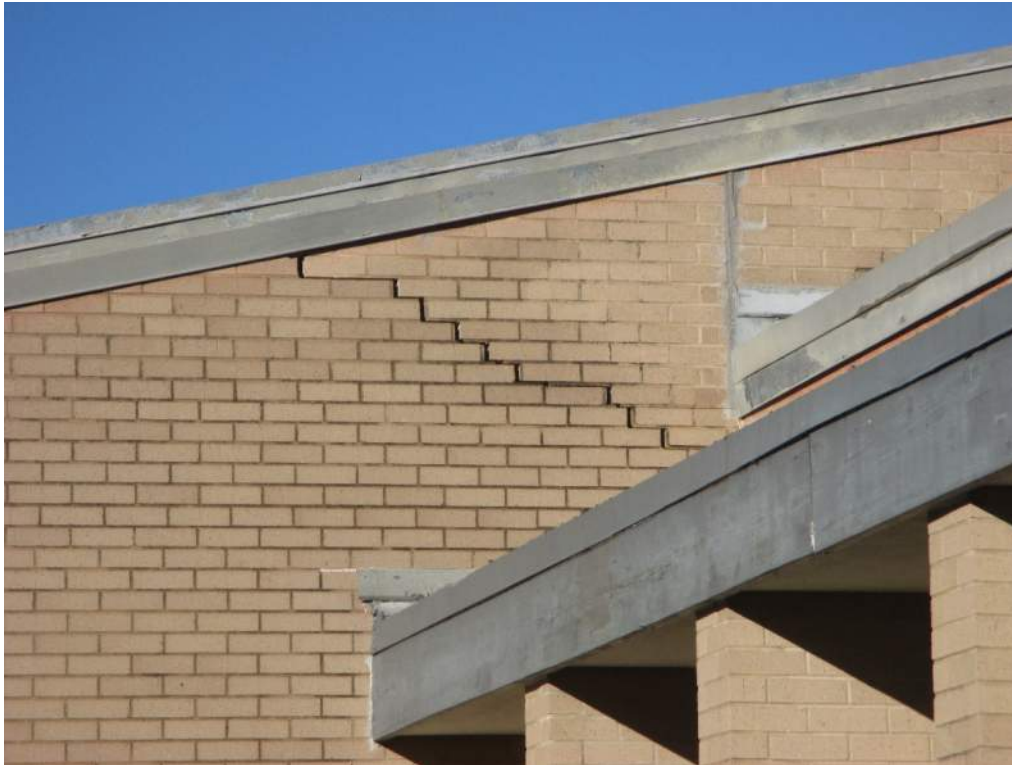
Photo 5: Close-up view of a crack in the brick veneer visible on the east face of the addition where the red arrow occurs in Photo 4.

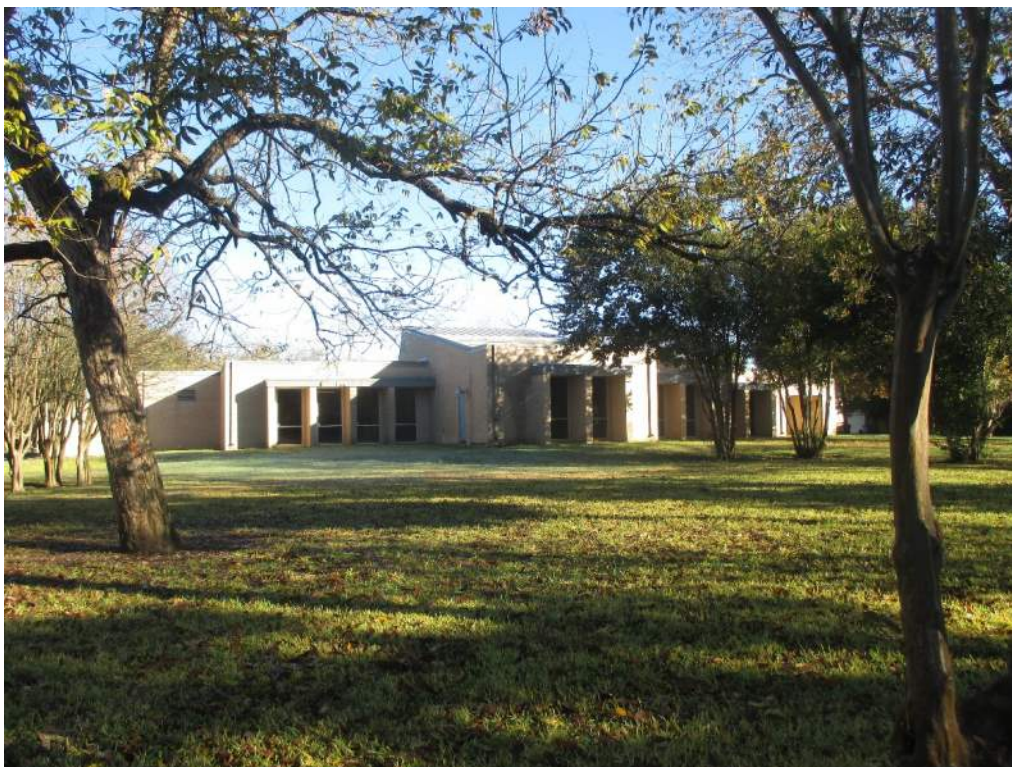
Photo 6: South face of building addition showing sloping roof over clerestory skylights.

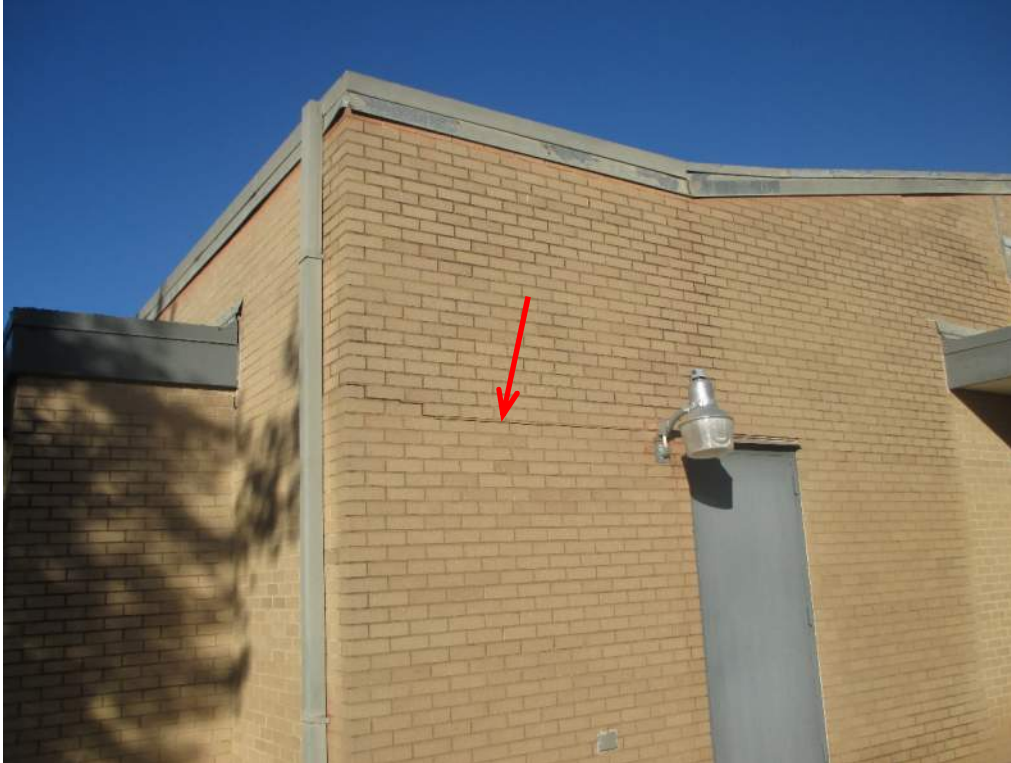
Photo 7: Horizontal crack in brick at top of door frame on east wall of addition. The cracked brick in Photo 5 is at the right side of this Photo. Note the torn sheet metal gravel guard at the top of the brick.

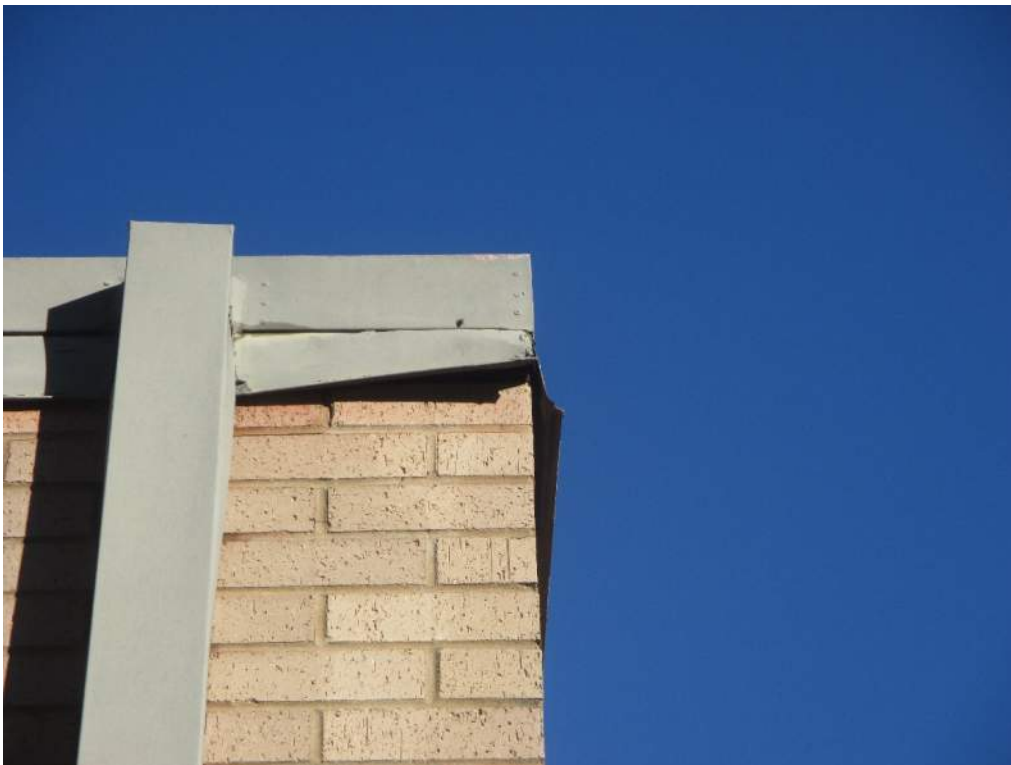
Photo 8: Close-up view of torn sheet metal gravel guard noted in Photo 7 caused by movement of the brick veneer in response to foundation movement.

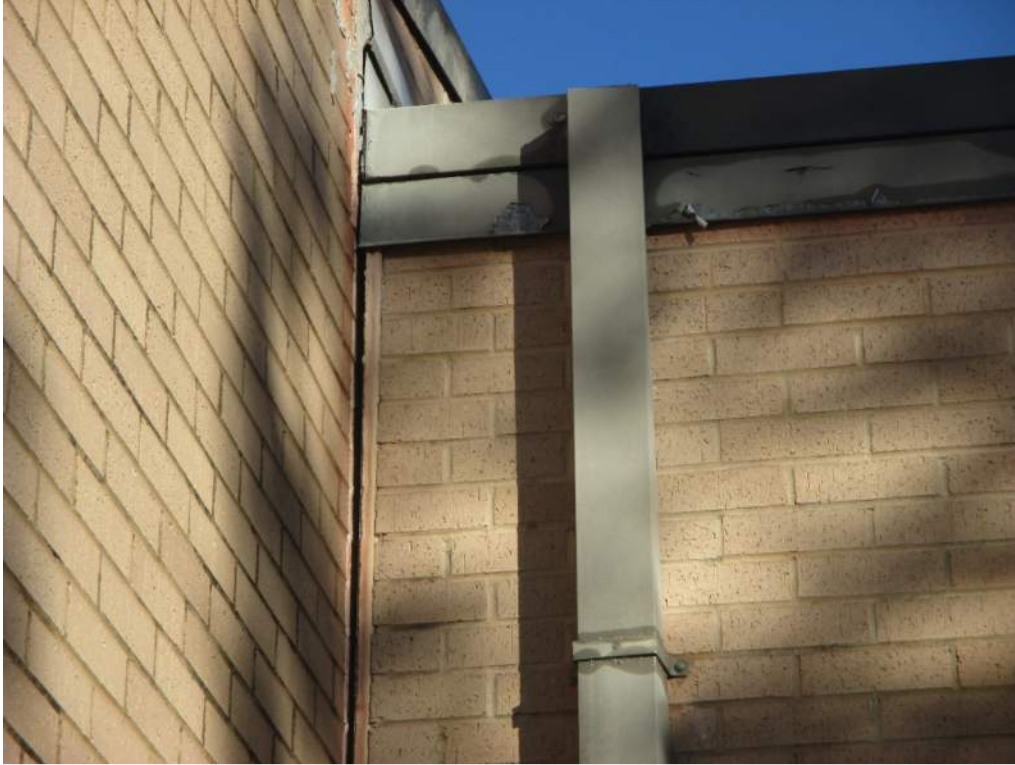
Photo 9: Separated sealant joint caused by foundation movement at re-entrant corner on south side of building.

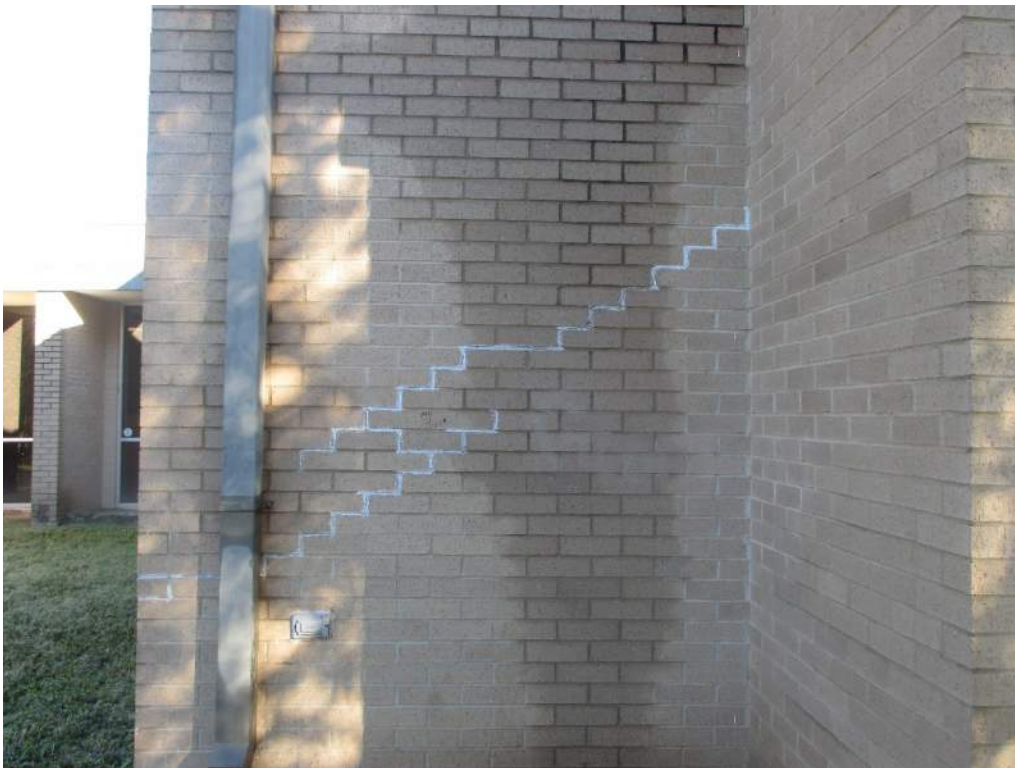
Photo 10: Crack in brick veneer at the south side of the 1985 addition filled with a cracked, non-matching sealant. The many reentrant corners in the Addition create stress risers in the brittle masonry veneer.

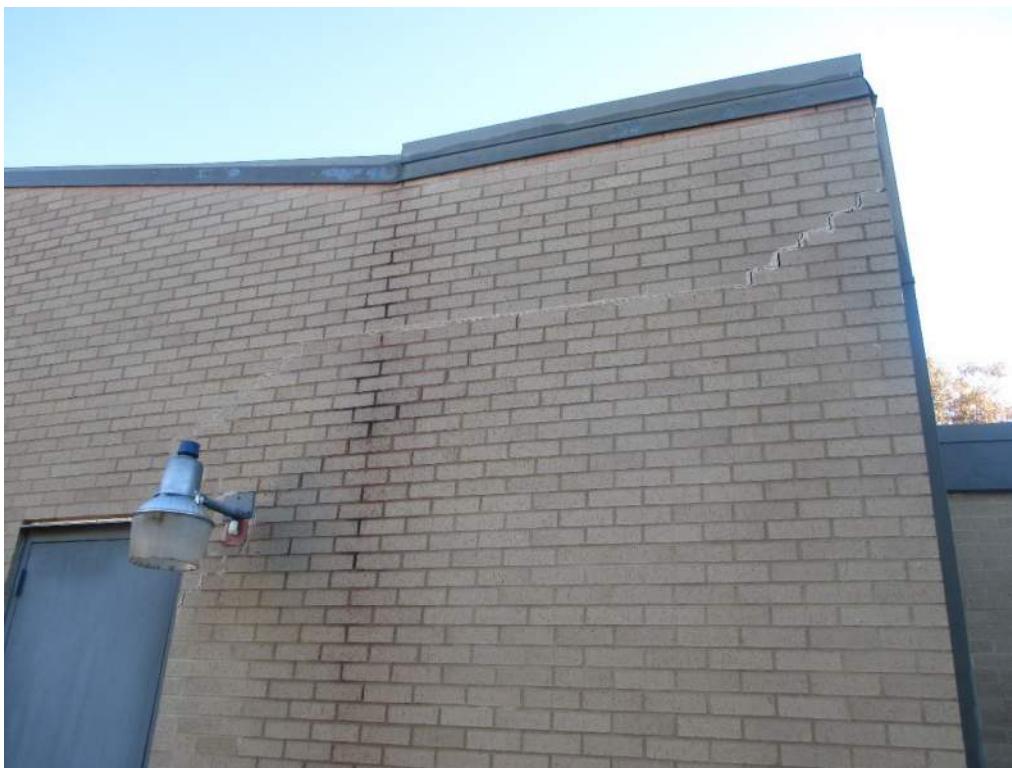
Photo 11: Crack in brick at the southwest corner of the addition.

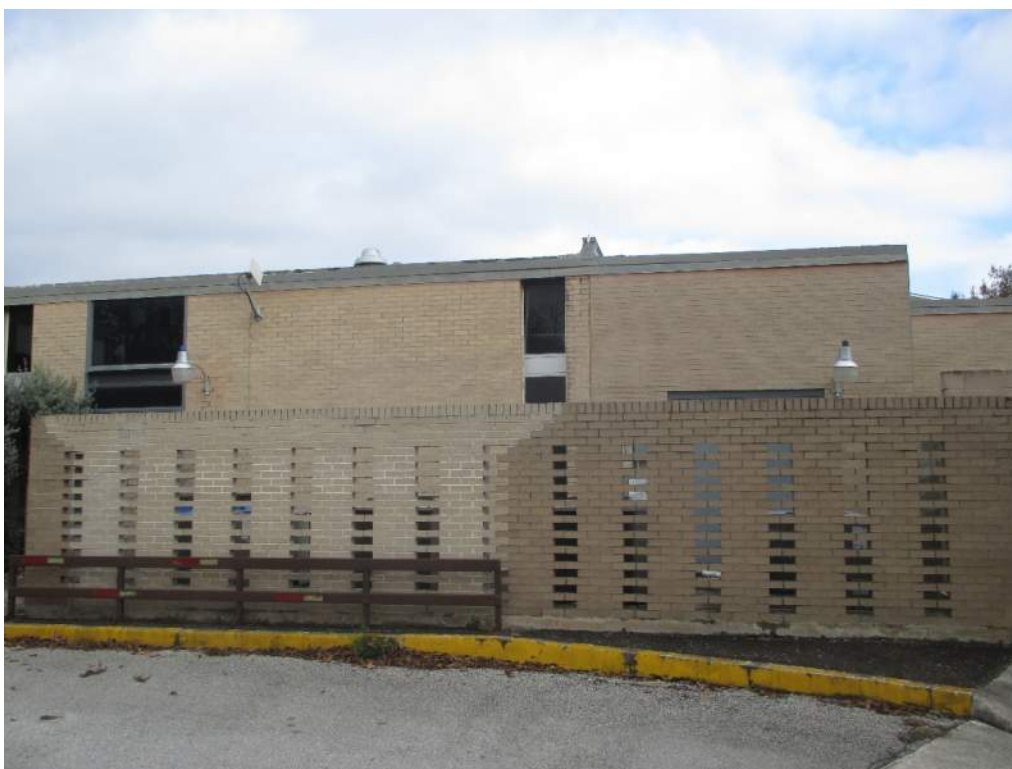
Photo 12: West face of building showing joint between original Library to left, and 1985 Addition to the right. Note the difference in brick color between 1964 and 1985 in the building and mechanical screen wall.

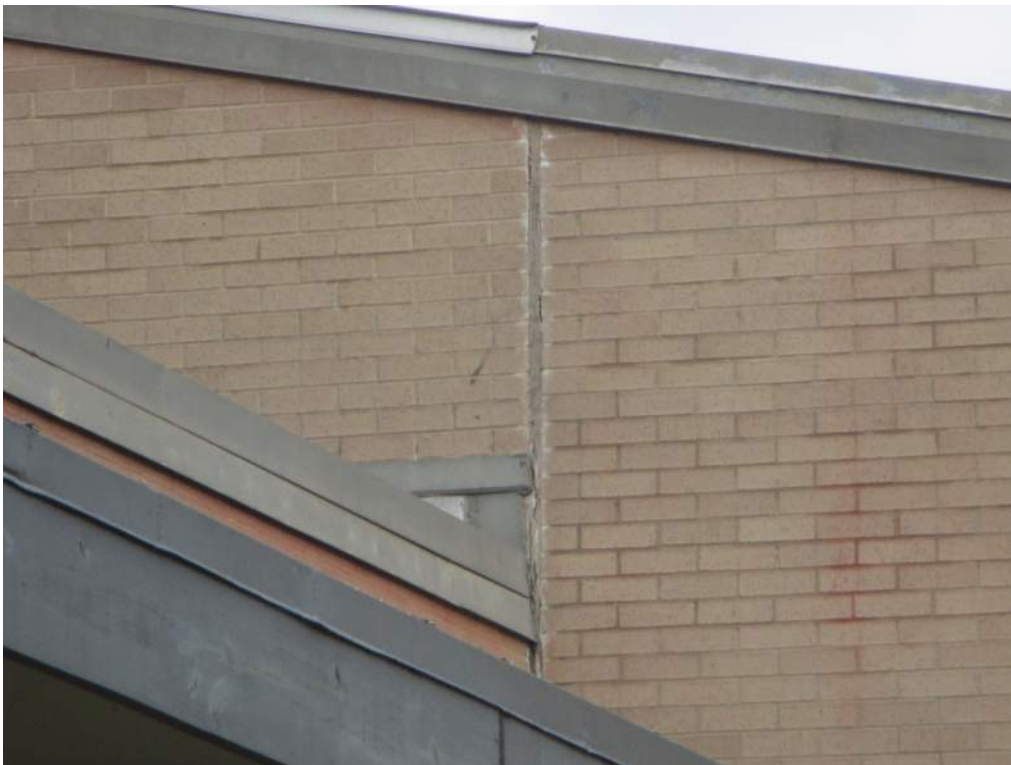
Photo 14: Close-up of cracked sealant in expansion joint shown in previous photograph.

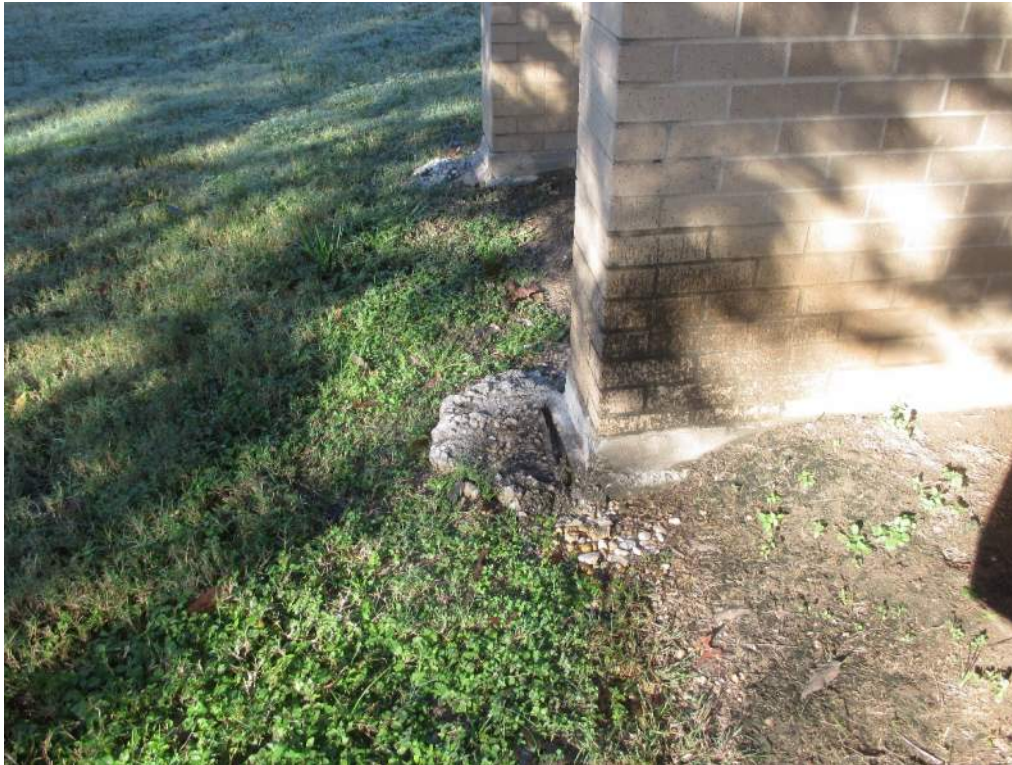
Photo 15: Excess exposed concrete extending beyond formwork line at the foundation for wingwalls on the south side of the addition.

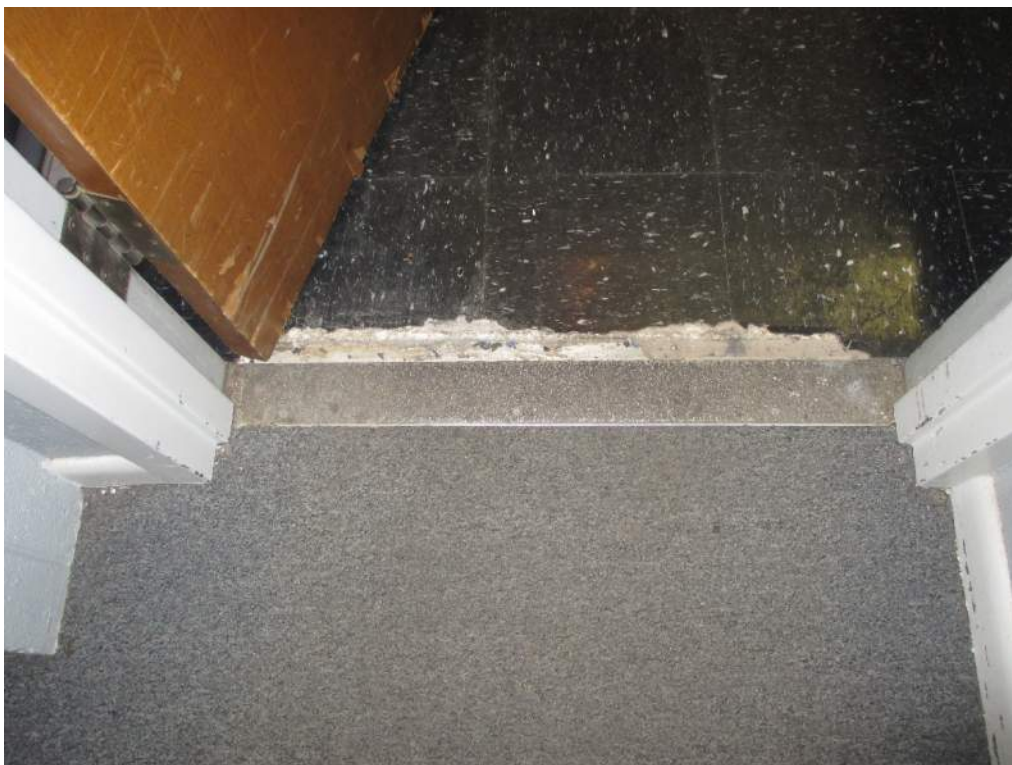
Photo 16: Condition of a floor joint at door into north meeting room of the original building.

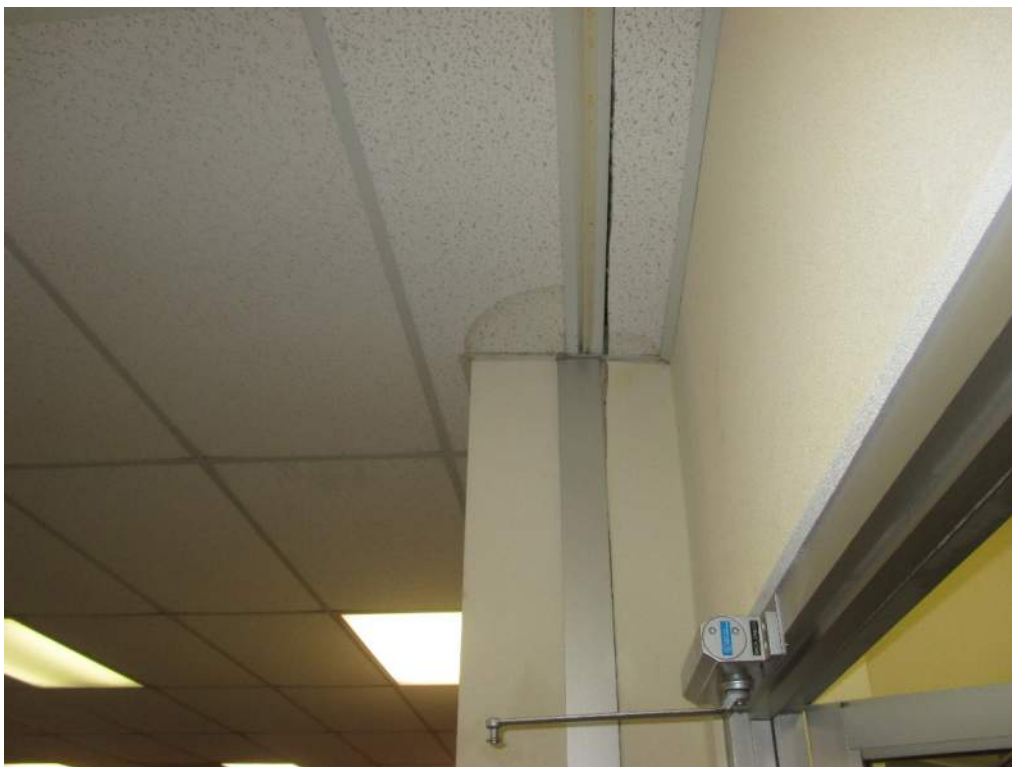
Photo 22: Ceiling expansion joint between the original building and new addition. Evidence of movement, and water staining on the ceiling.
