FEASIBILITY ASSESSMENT REPORT

Old Library
707 East College Street

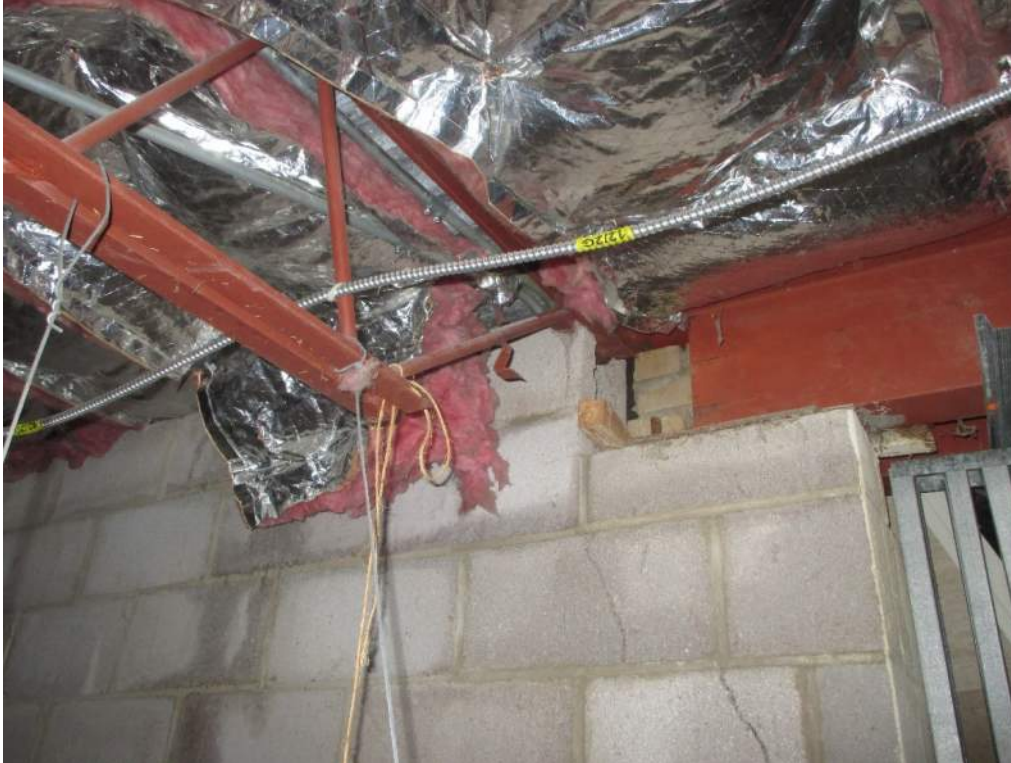
Photo 23: Existing damaged load bearing CMU wall (on east side of the activities/meeting room located west of front entry doors). The steel beam was part of the Addition work, and the joist is part of the original construction. Both the joist and beam have inadequate bearing on the partially removed and cracked CMU. This condition requires structural repair prior to reoccupying the building.

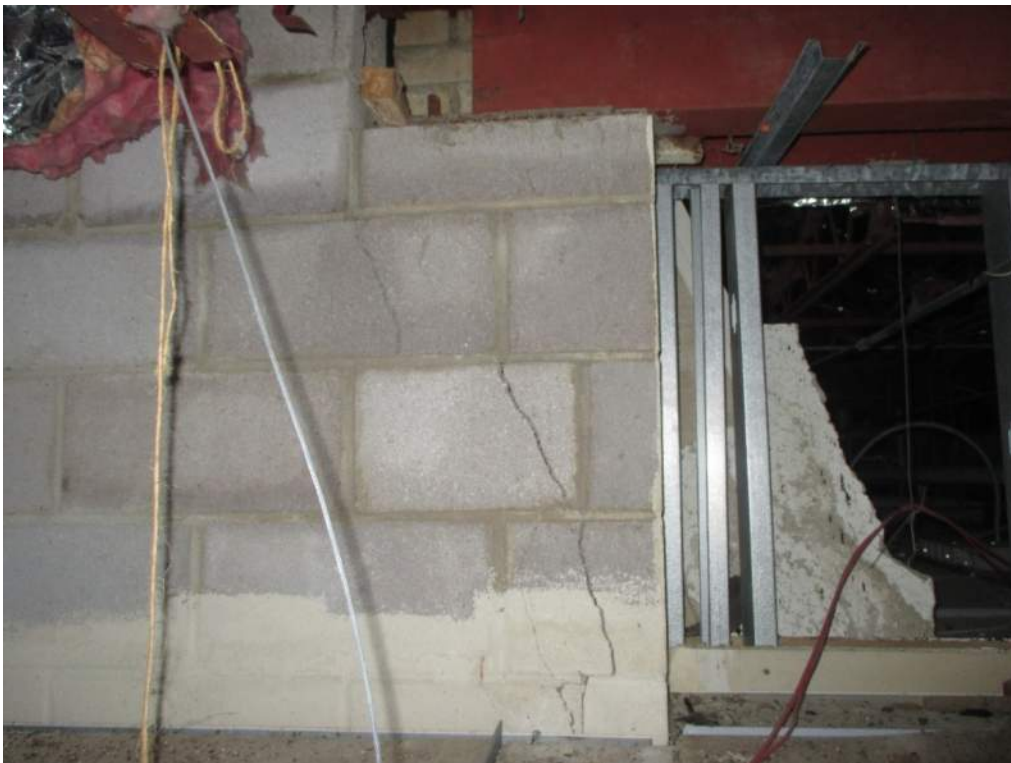
Photo 24: Another view of the cracked load bearing CMU (shown in previous photo) under the steel roof beam.

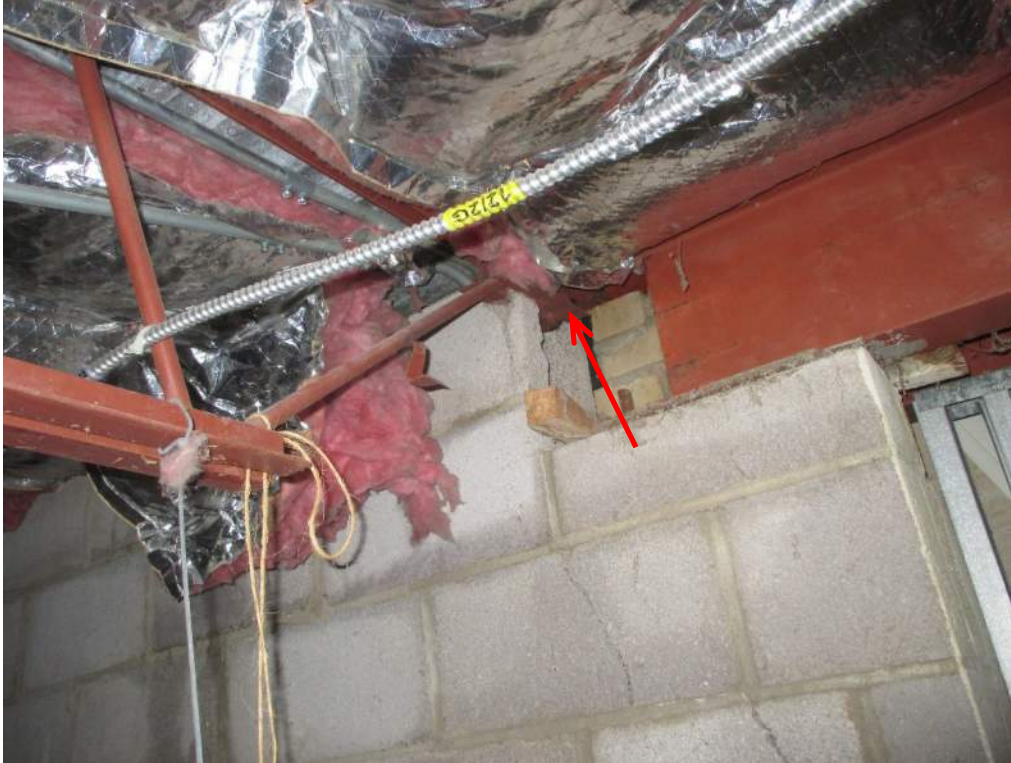
Photo 25: Close-up view of the inadequate joist bearing on the CMU wall. Half of the joist bearing seat no longer has supporting CMU under the seat, and the remaining CMU is cracked.

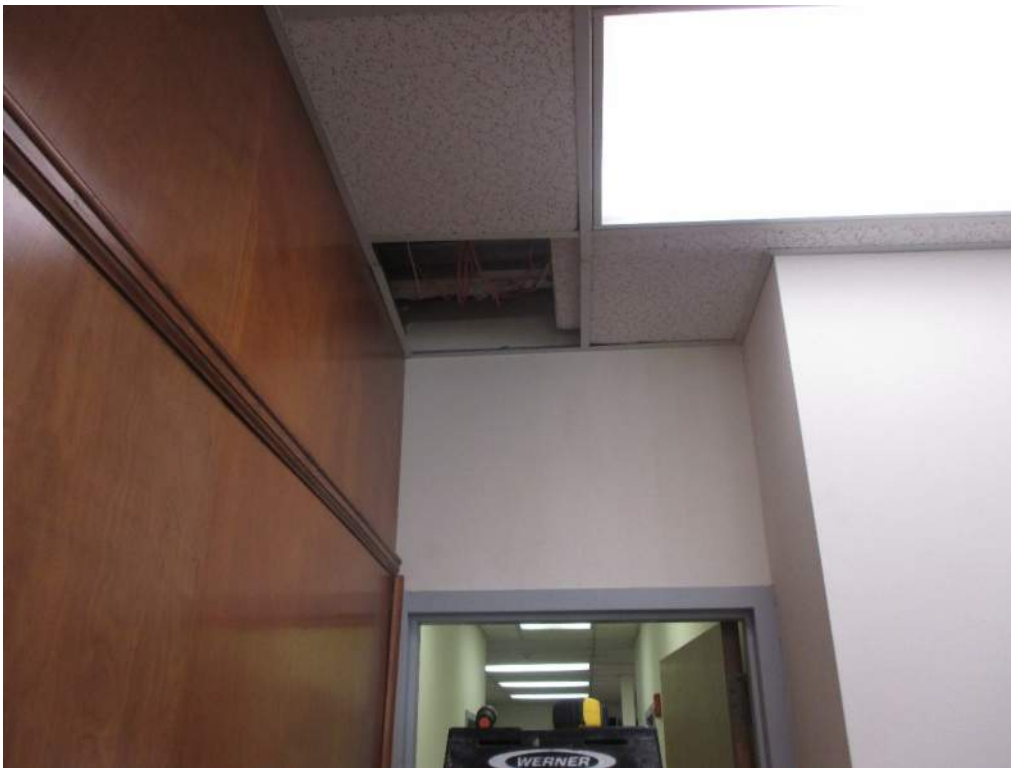
Photo 26: View looking north into the administrative office area of the original building from the Addition. The original load bearing CMU wall and brick veneer were cut through at this location in the 1985 Addition work.

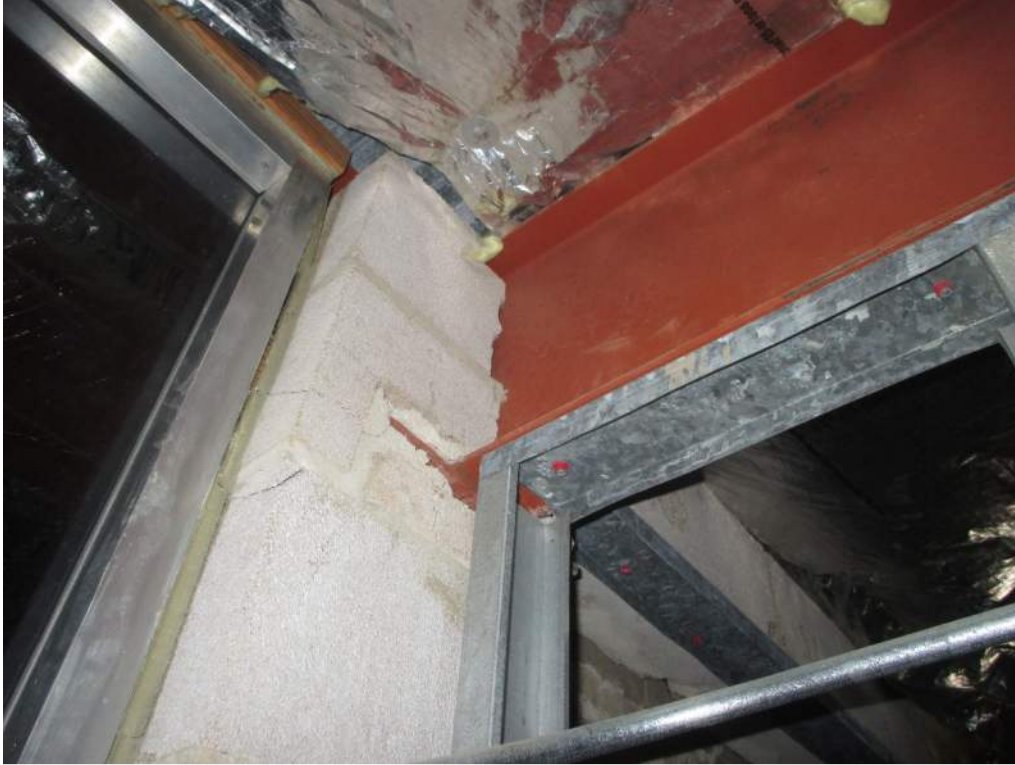
Photo 29: Existing load bearing CMU the was partially removed at the location of the previous photos. An existing original window is visible to the left that was covered over with metal stud wall framing at the Addition. The remaining CMU supporting the beam is cracked and damaged.

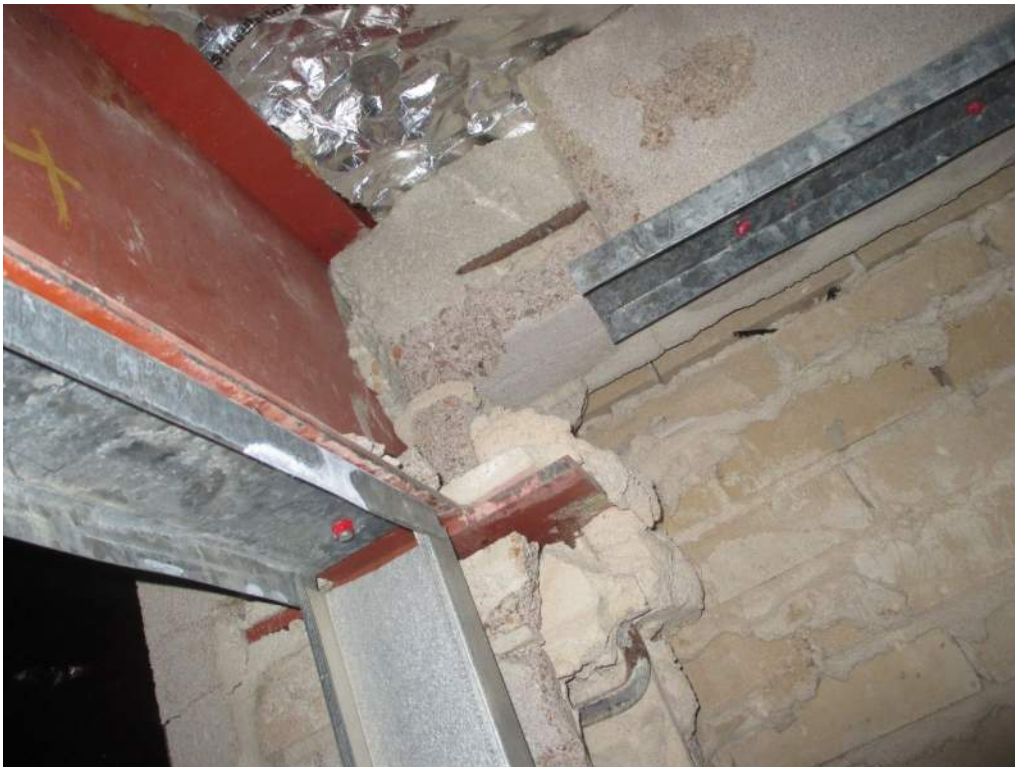
Photo 30: Another view of the end of the partially demolished CMU bond beam, and inadequate bearing for the steel roof beam shown in the previous photo. This condition requires structural repair prior to reoccupying the building.

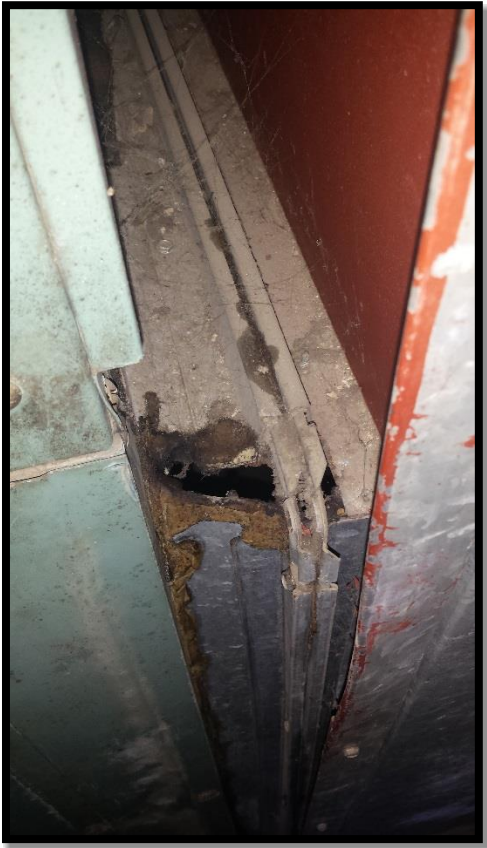
Figure 1 – Ductwork damage on AHU-1

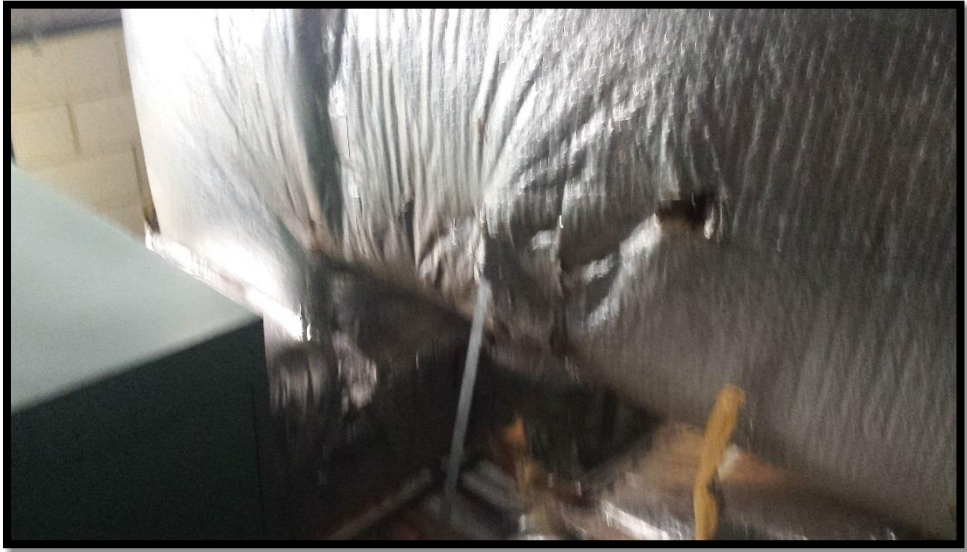
Figure 2 – Insulation damage near AHU-3

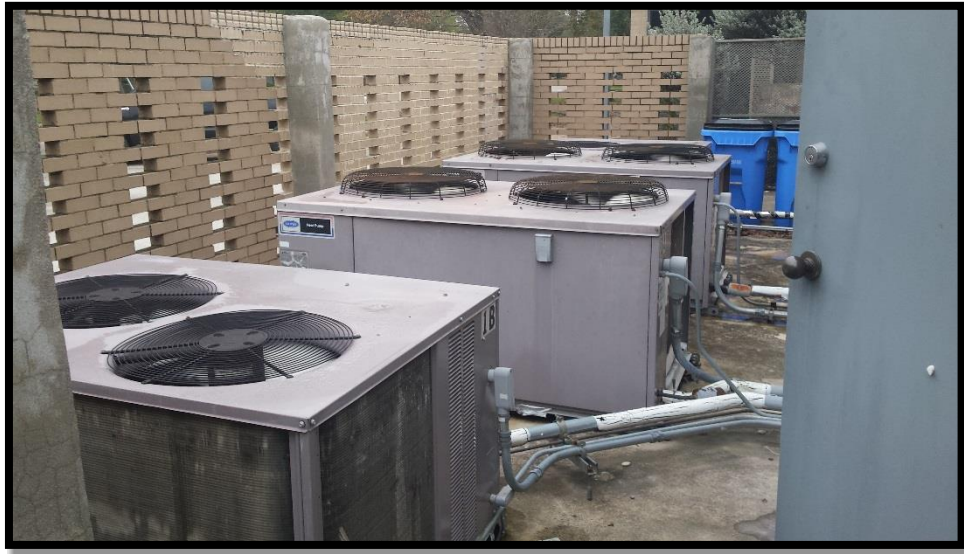
Figure 3 – Heat pump yard

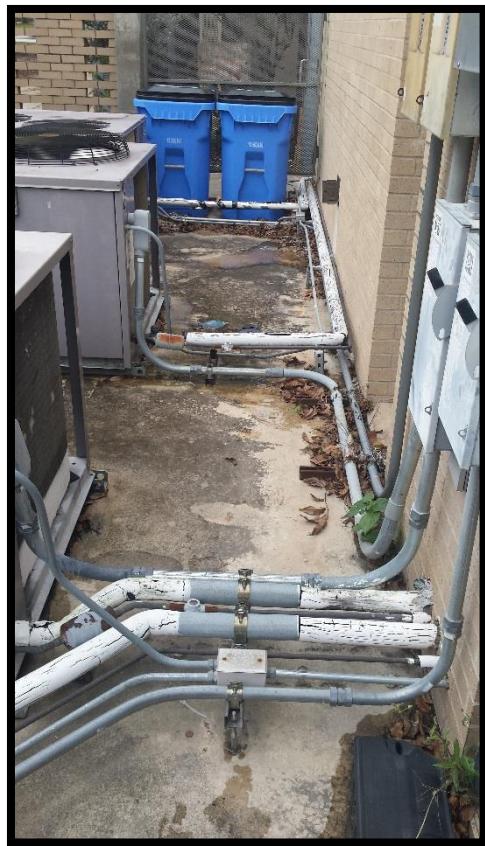
Figure 4 – Refrigerant piping insulation damage

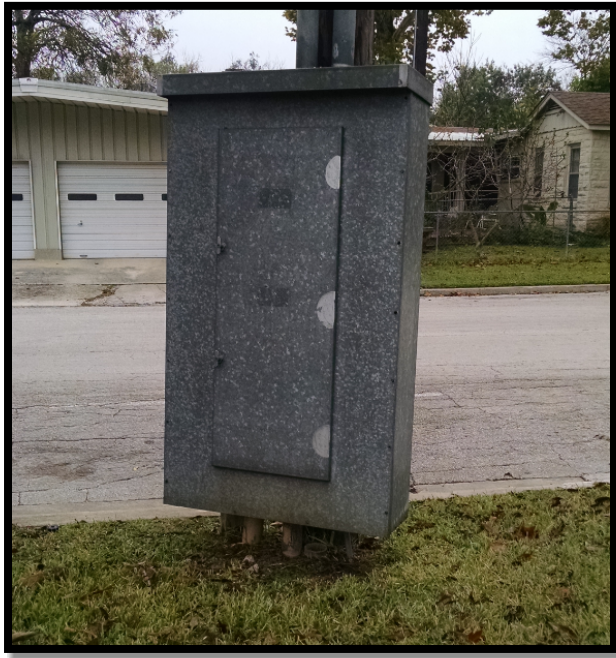
Figure 5 – Electrical Service

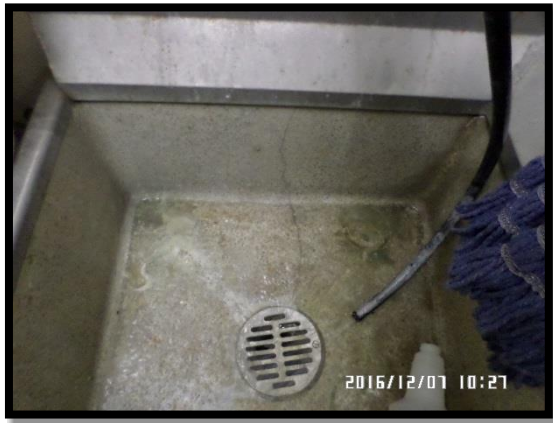
Figure 10 – Cracked Mop Basin

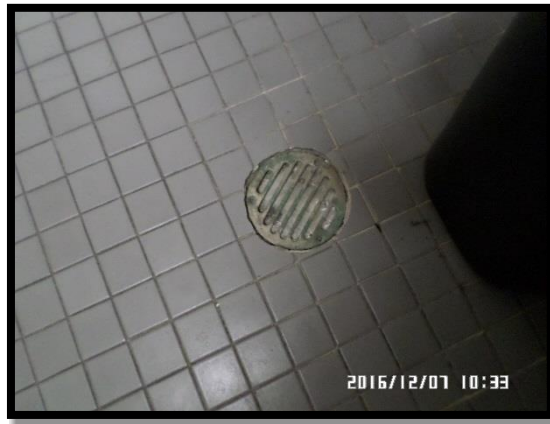
Figure 11 – Blocked Floor Drain

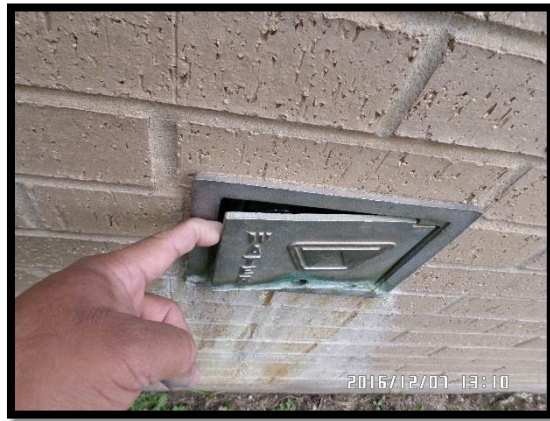
Figure 12 – Damaged Wall Hydrant

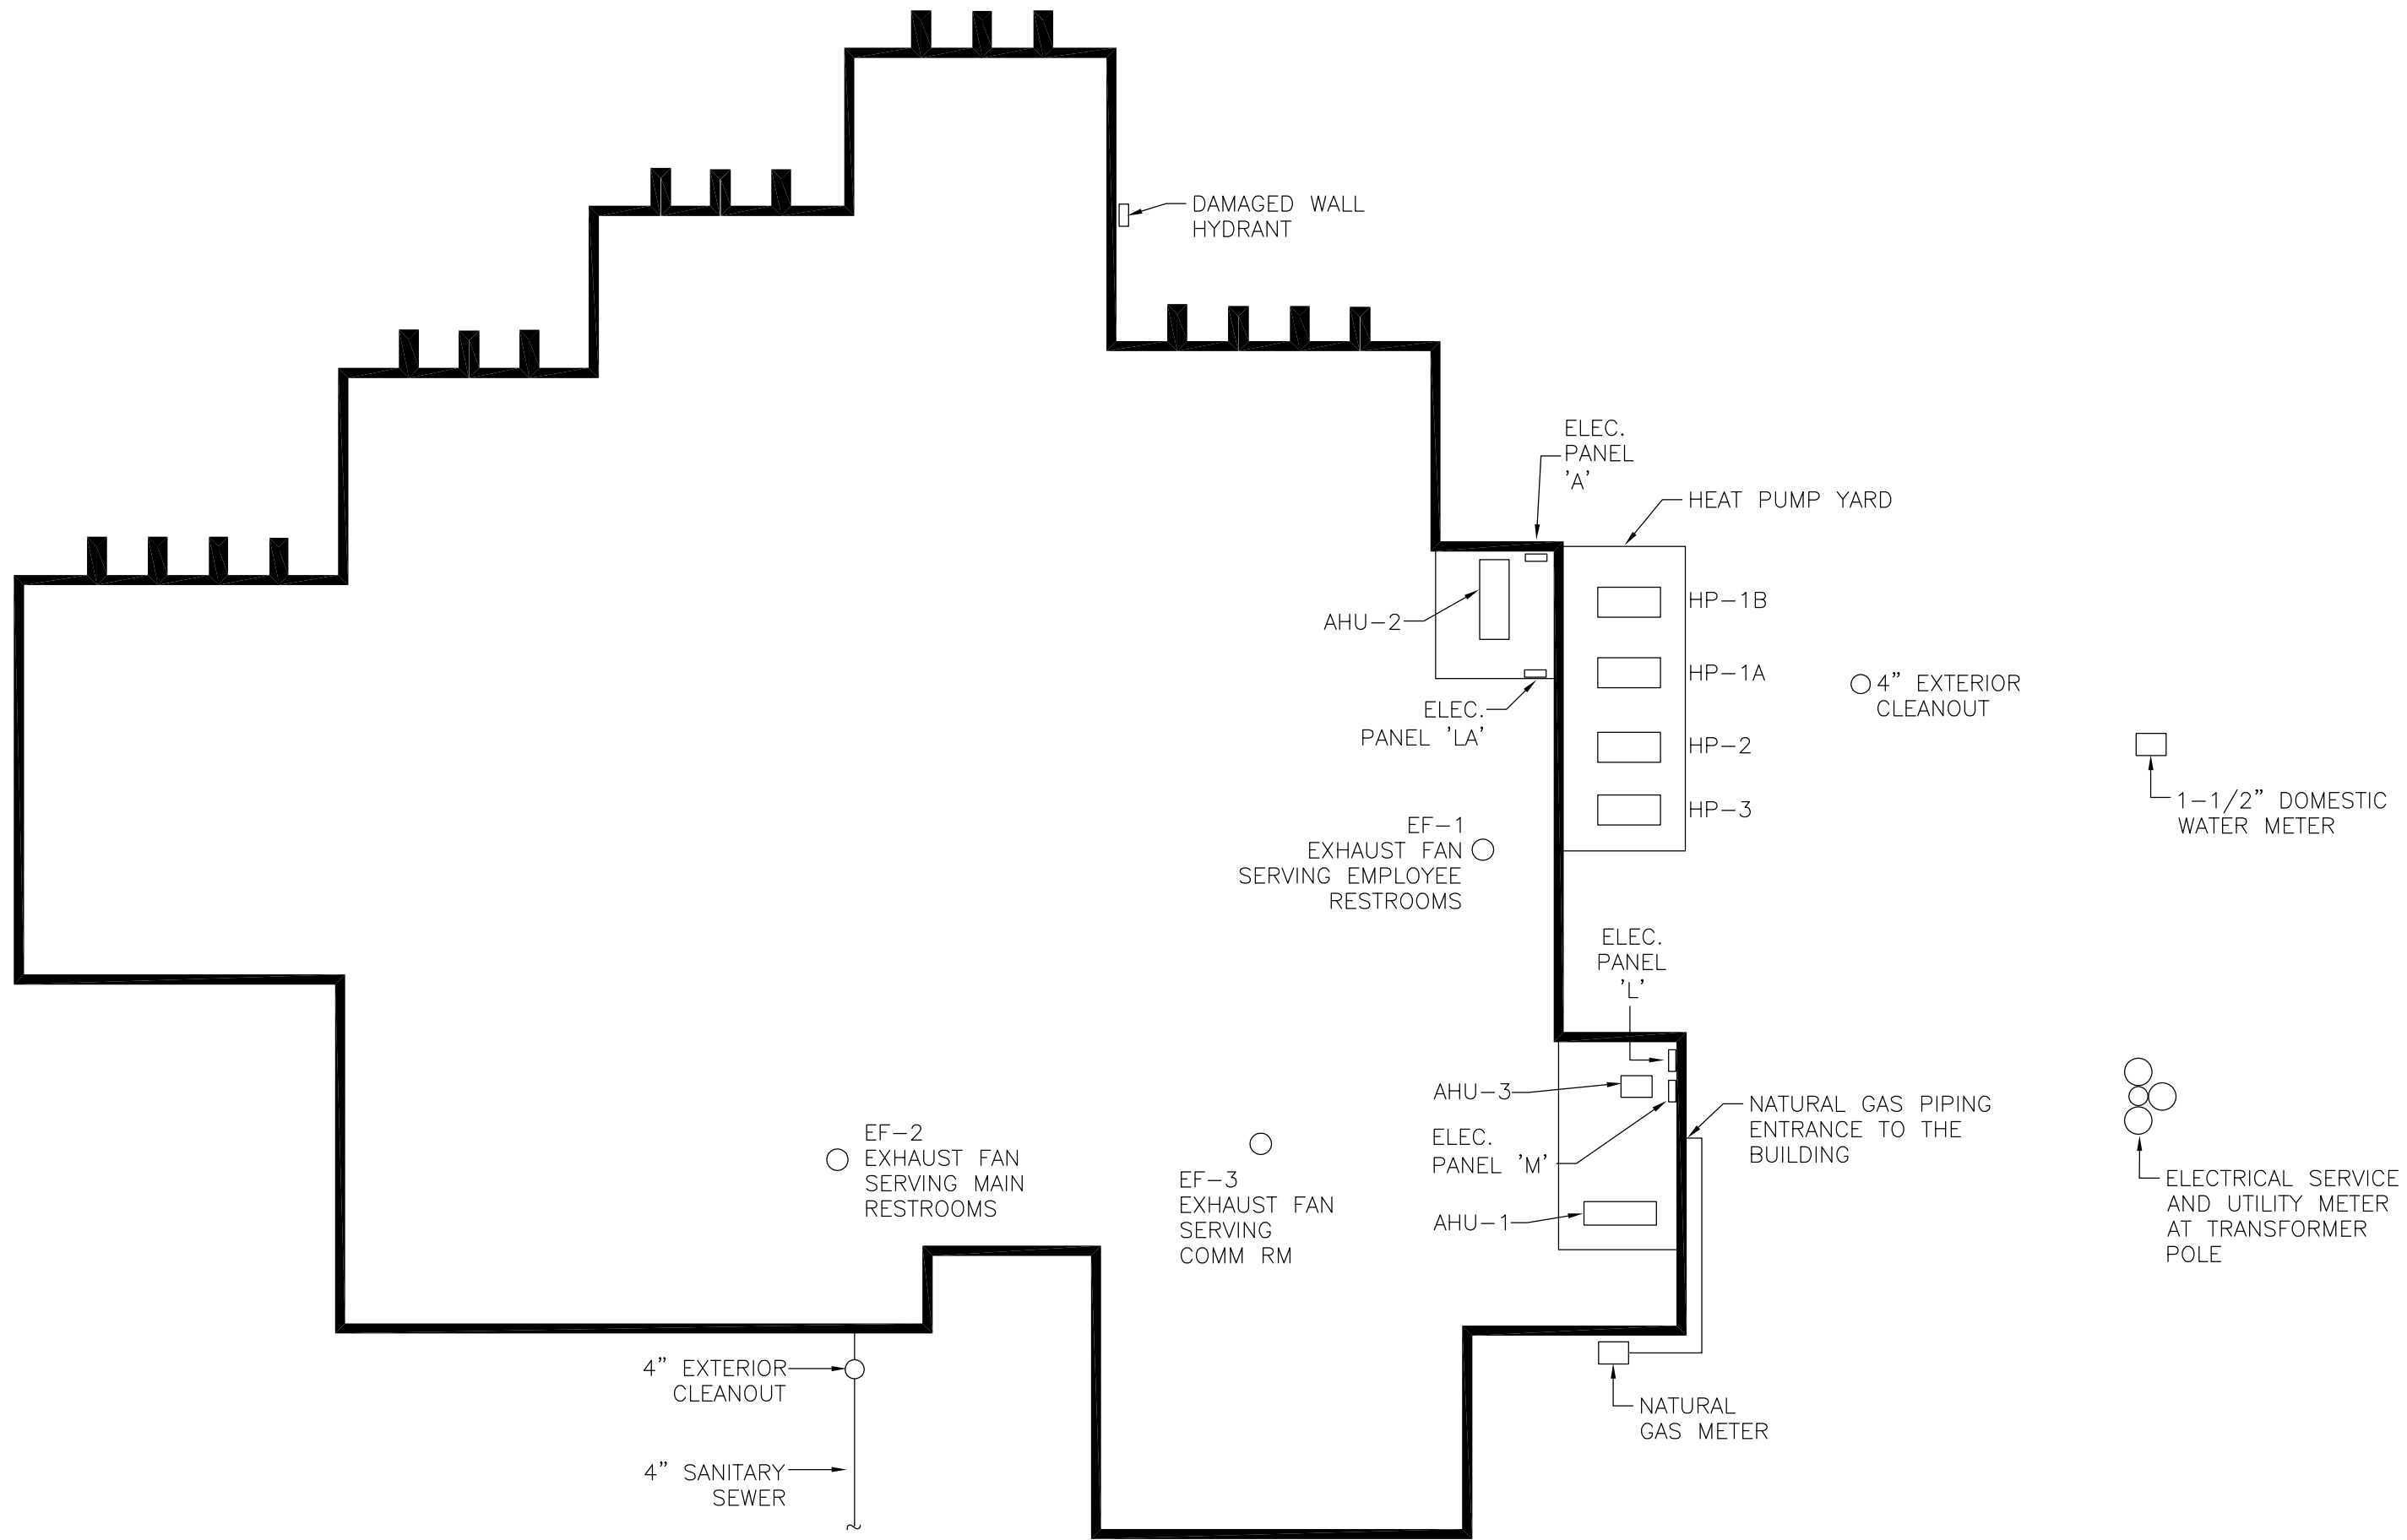
M&S ENGINEERING
 MECHANICAL, ELECTRICAL, PLUMBING & STRUCTURAL ENGINEERS
 1100 W. UNIVERSITY BLVD., SUITE 200
 SPRING BRANCH, TEXAS 78070

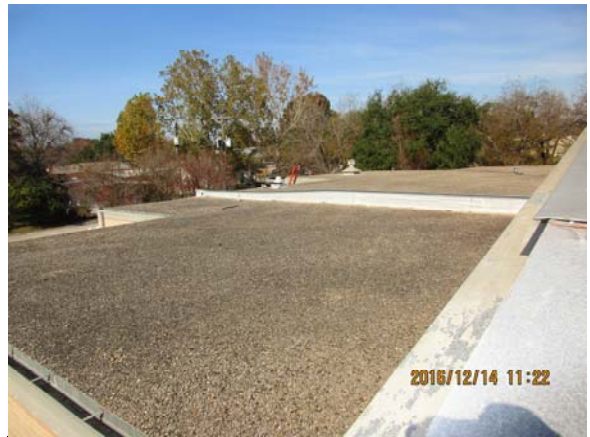
Overview of the roof membrane at the Facility.

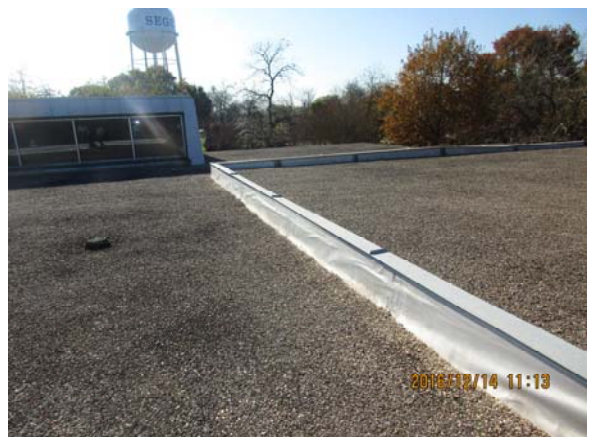
Overview of vertical membrane flashings. Note the wrinkling and delamination of the flashing. Note the expansion joint cover on the joint shown.

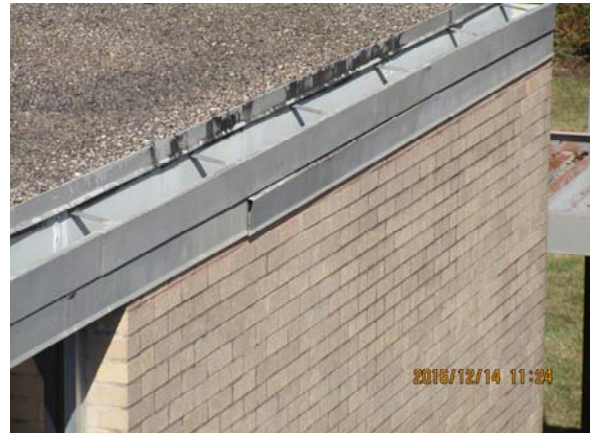
Overview of the low-sloped roof edge. Note the staining of the membrane above the flashing and the open lower flashing joint.

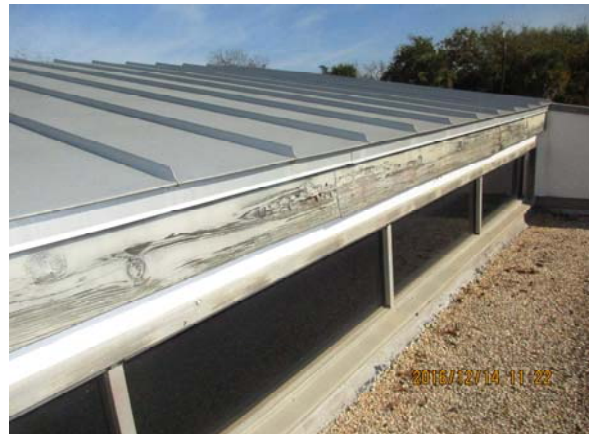
Overview of the metal roof edge and deteriorated wooden fascia.

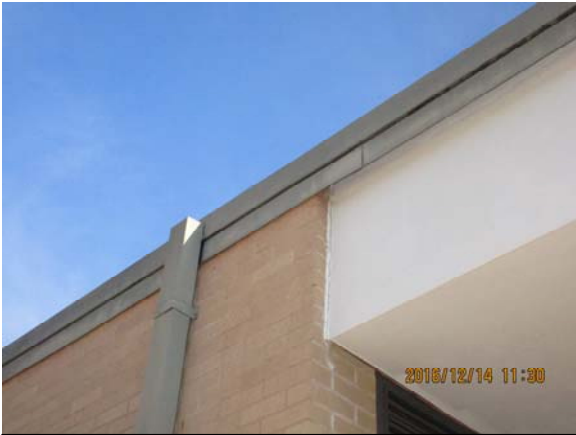
Overview of roof edge guttering. Note the downspout outlet is through the face of the gutter as the gutter is installed on a recessed ledge.

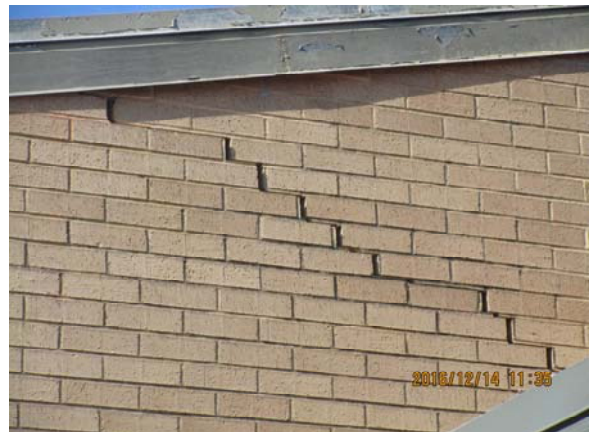
Cracking at an exterior brick veneer wall.

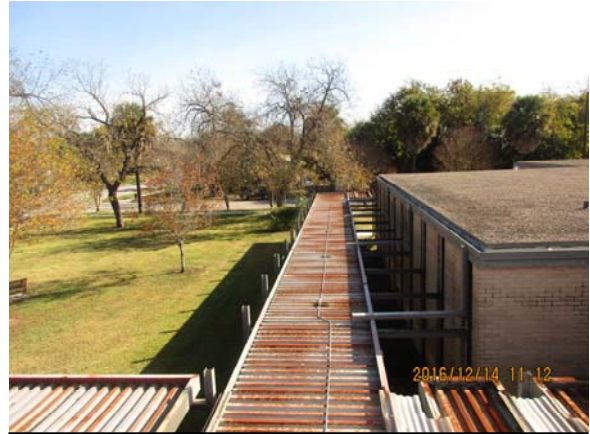
Overview of covered canopy walkways.
