# Walnut Springs Spillway and Bank Stabilization Repair

Project Planning Memorandum

*Seguin, Texas*  
June 6, 2024

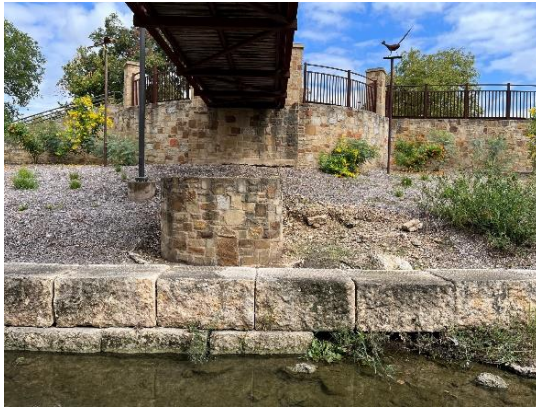
1) East Bank – Bank erosion behind elevated manhole

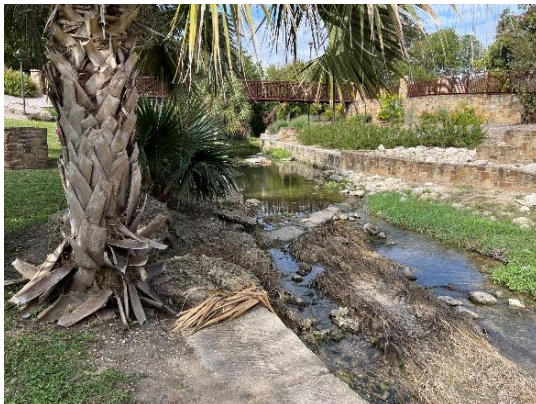
5) West Bank – Concrete toe repair at existing utility

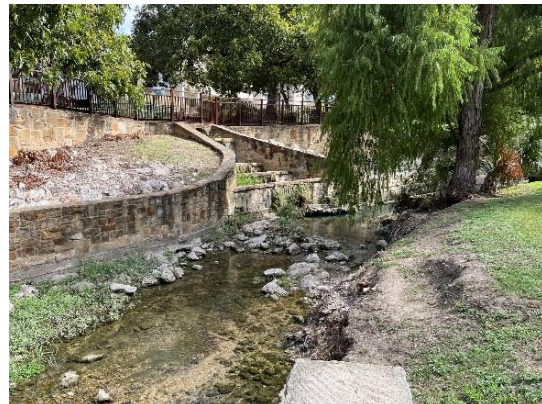
6) West Bank – Minor erosion along unarmored bank

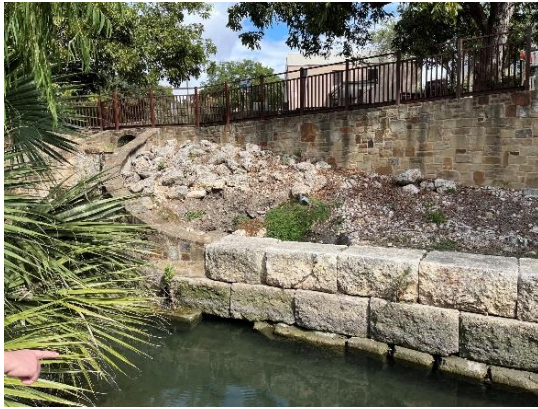
7) East Bank – Missing footer and major scour behind wall

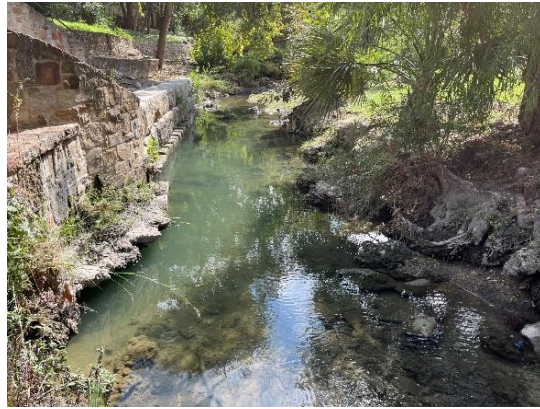
8) Looking downstream – channel downcutting

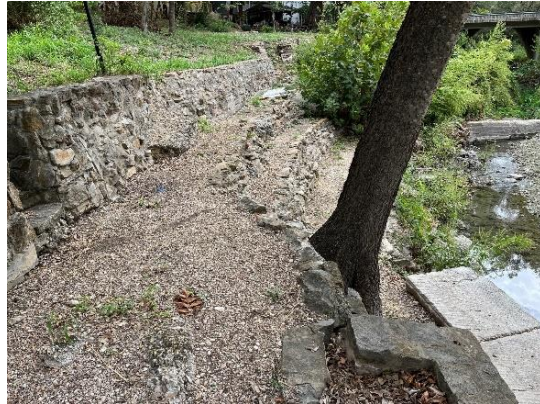
12) East Bank – no observed erosion, stacked stone terraces (non-structural)

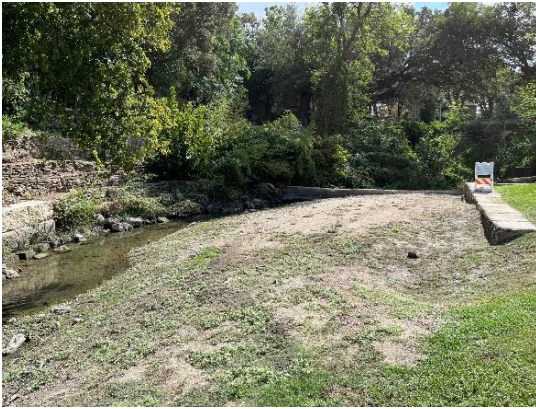
13) Looking downstream (low head dam) – sedimentation

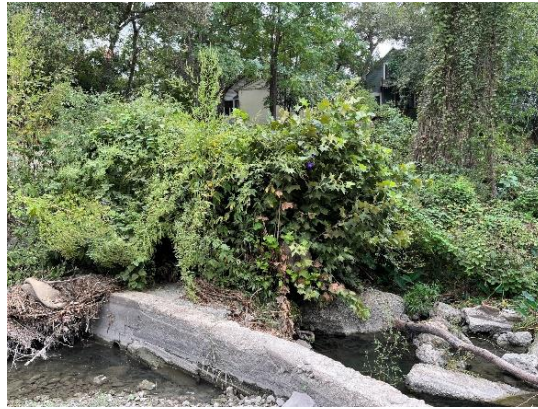
14) East Bank – Flanking of low head dam, sycamore tree root ball failure

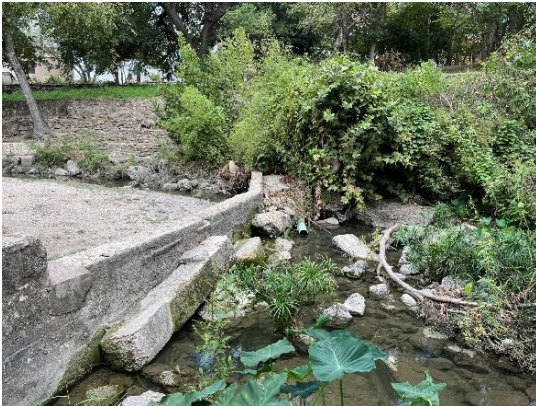
15) Damage to low head dam

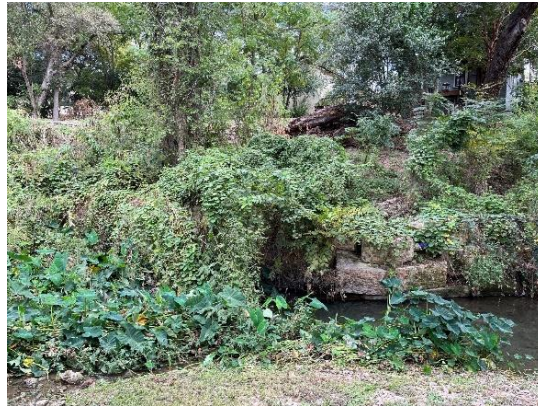
16) East Bank – Block wall failure

For the east bank downstream of the low head concrete spillway, a full replacement of the existing failed limestone block wall is recommended because the upstream end at the low head dam is flanked and unprotected, and additional wall failures were observed downstream. The failed wall could be replaced with a 160 LF combi wall system which includes a combination of king piles connected with sheet piles (See Section 4.3.1). The exposed face of the combi wall would be the steel sections. A concrete cap is proposed for the top of the combi wall system; therefore, the proposed combi wall would have a similar aesthetic to the concrete capped sheet pile wall in Max Starcke Park along River Drive West and the Guadalupe River (Figure 5-1).

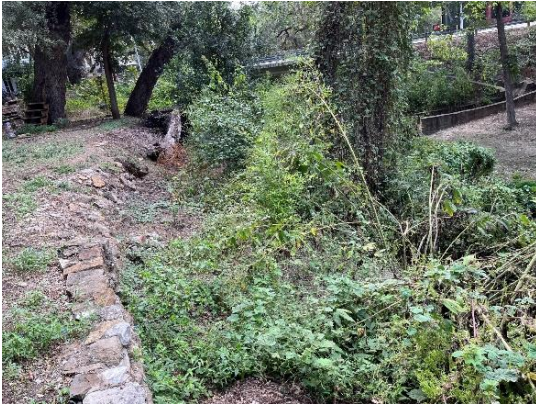
17) East Bank – top of bank above sycamore tree root ball failure

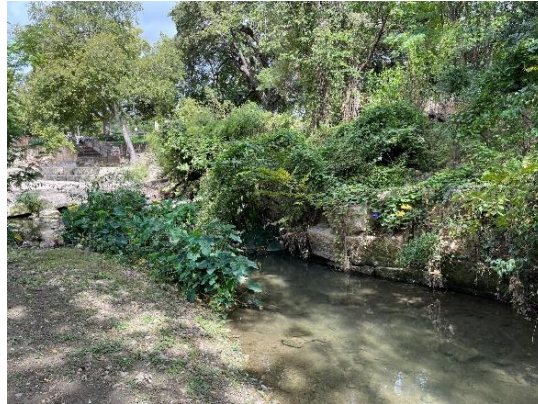
18) East Bank – Looking upstream at block wall failure near low head dam

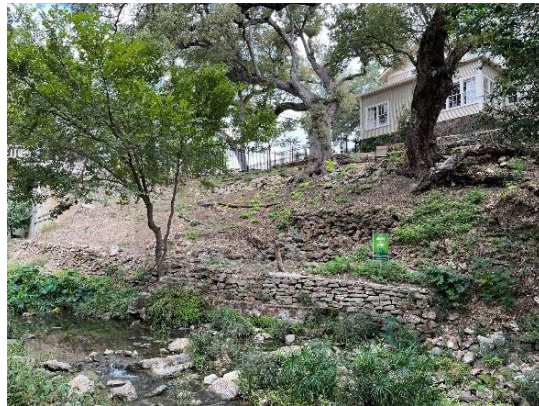
19) East Bank – dry stack limestone chop stone

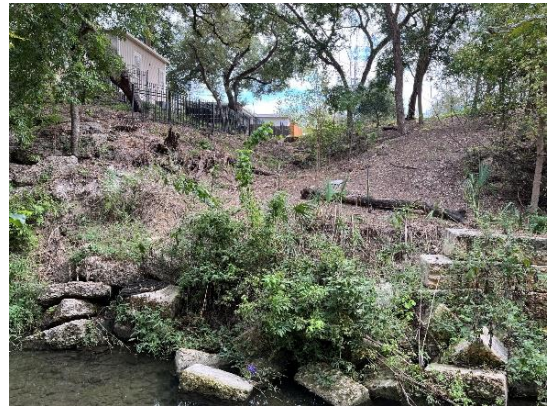
20) East Bank – Upstream failure of 2015 USACE block wall

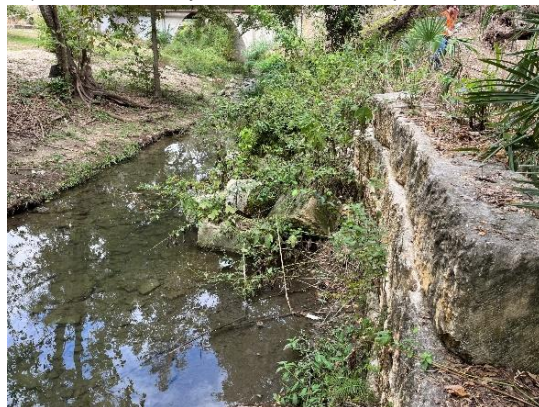
21) East Bank – Looking upstream along intact wall

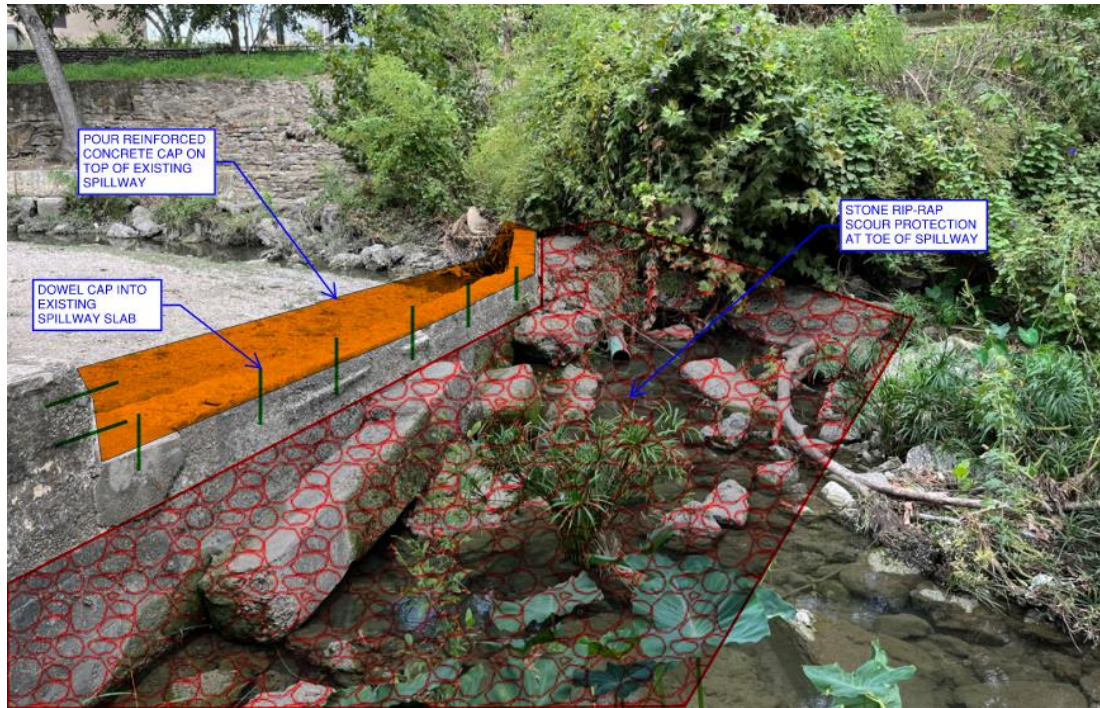
**Figure 4-4. Conceptual Spillway Crest Repair Alternative**

The sedimentation observed behind the spillway is expected to continue. Sediment will collect to the elevation of the restored crest. The upstream source of the sediment is unknown but could be from urban runoff in the watershed or from erosion of bed and banks upstream. If sediment sources cannot be addressed, one strategy for managing sediment is to have a dedicated sediment sink or trap where sediment will collect and access allows for its continual removal. The existing spillway currently serves as a sediment trap and has reasonable equipment access. The spillway also serves as grade control for the upstream reach. A higher, restored crest may offer more protection against downcutting of the upstream stream bed. Since the sediment load is from upstream sources and the low head dam is proposed to remain, sedimentation upstream of the structure will continue to be a maintenance activity. There is not a crest configuration that would significantly impact the sedimentation rate.

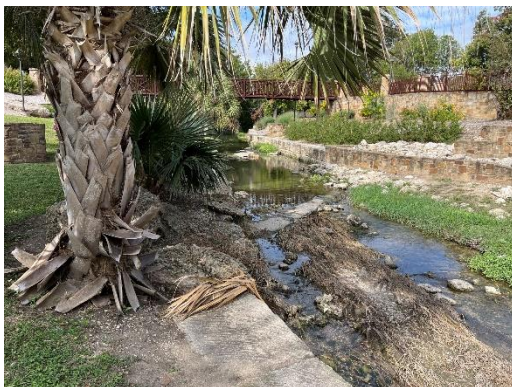
5) West Bank – Concrete toe repair at existing utility

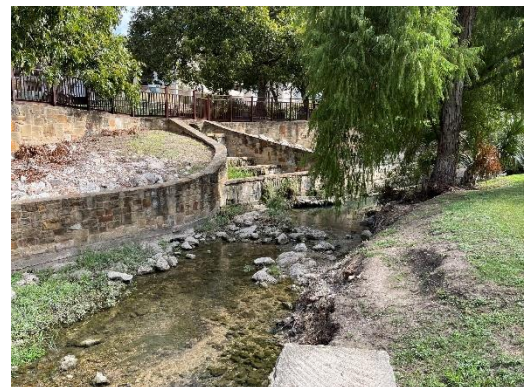
6) West Bank – Minor erosion along unarmored bank

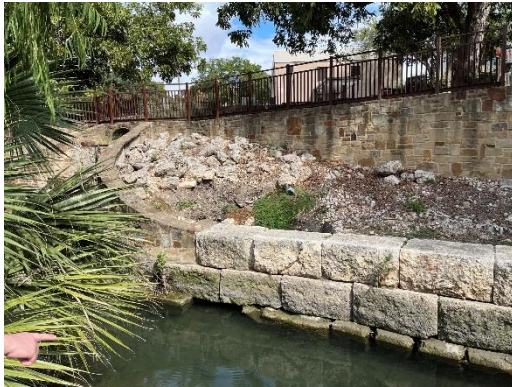
7) East Bank – Missing footer and major scour behind wall

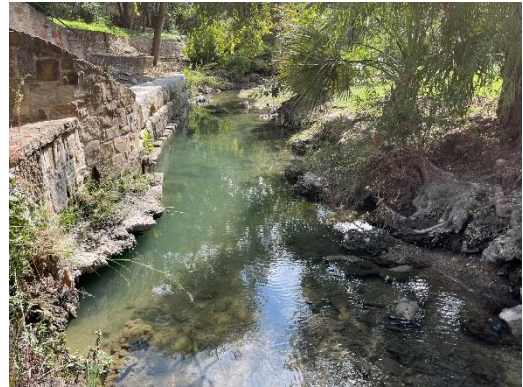
8) Looking downstream – channel downcutting

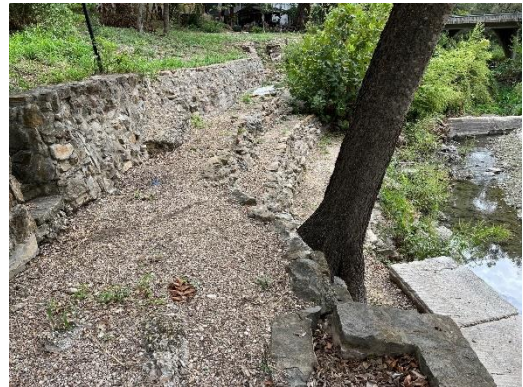
12) East Bank – no observed erosion

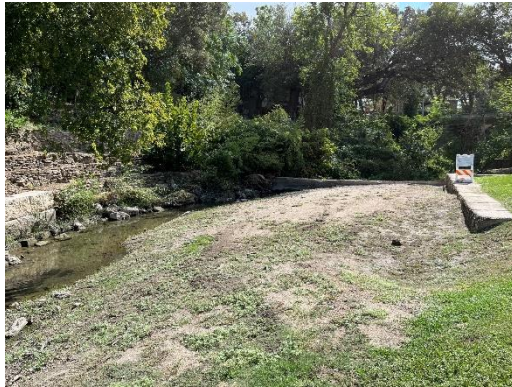
13) Looking downstream (low head dam) - sedimentation

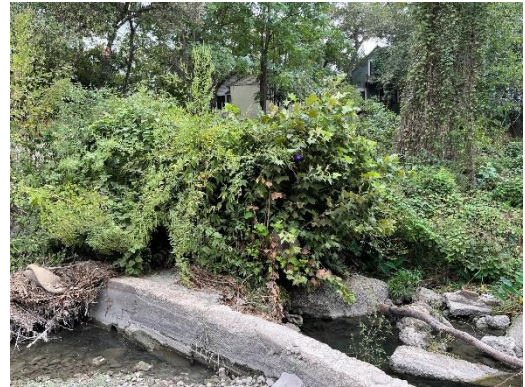
14) East Bank – Flanking of low head dam, sycamore tree root ball failure

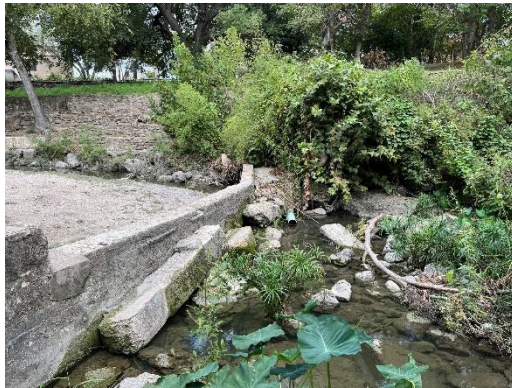
15) Damage to low head dam – looking east

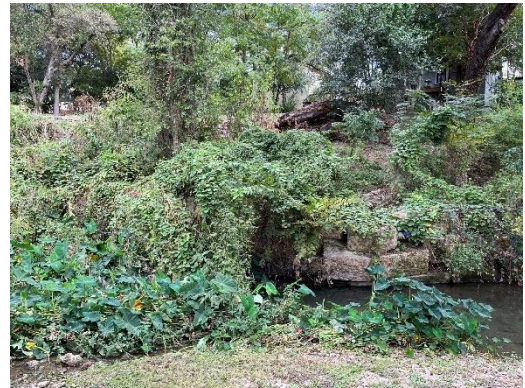
16) East Bank – Block wall failure

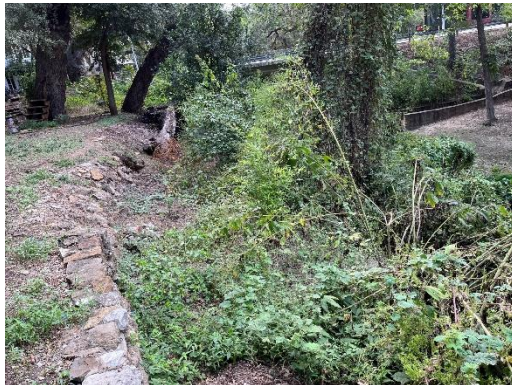
17) East Bank – top of bank above sycamore tree root ball failure

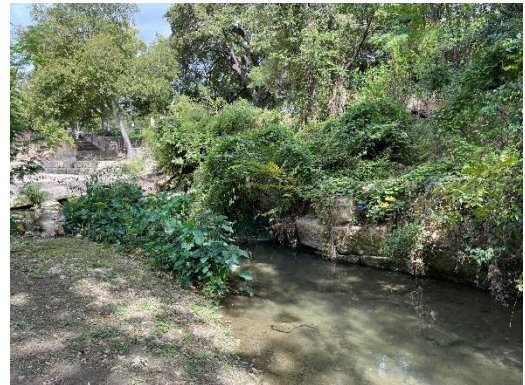
18) East Bank – Looking upstream at block wall failure

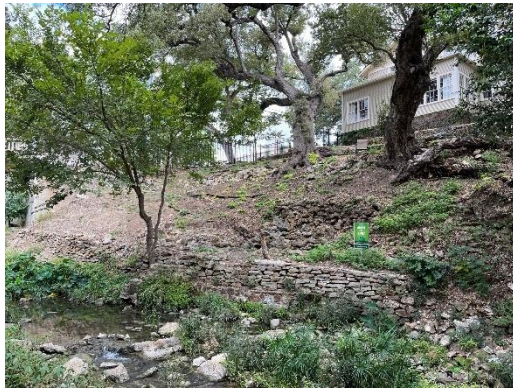
19) East Bank – dry stack limestone chop stone walls

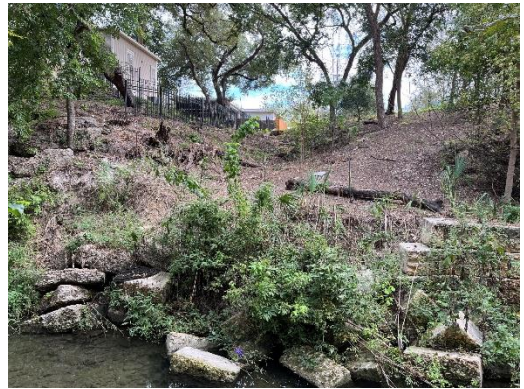
20) East Bank – Upstream failure of 2016 USACE block wall

For Site 2, the upstream end of the block wall has been flanked (photograph 20) and the materials are unstable, but additional failure along this wall was not observed. While the risk of additional failure may exist because of uncontrollable factors, the consequence of failure at each site is different and should be considered by the City in Phase 2.

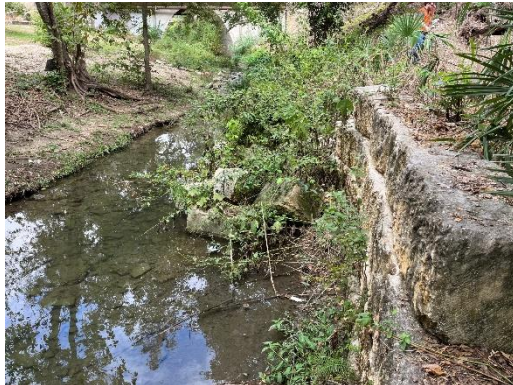
21) East Bank - Looking upstream along intact wall

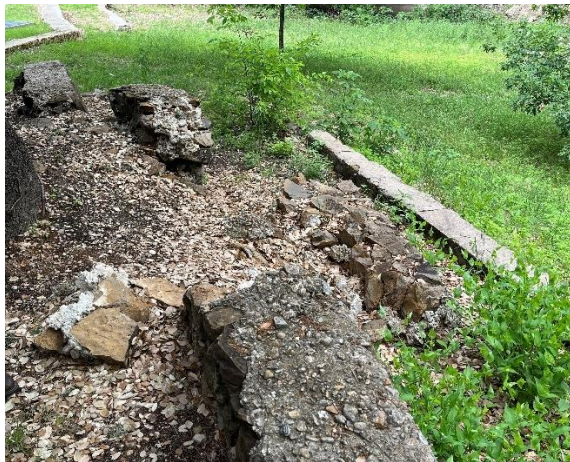
27) West Bank – failed historic stone walls along trail

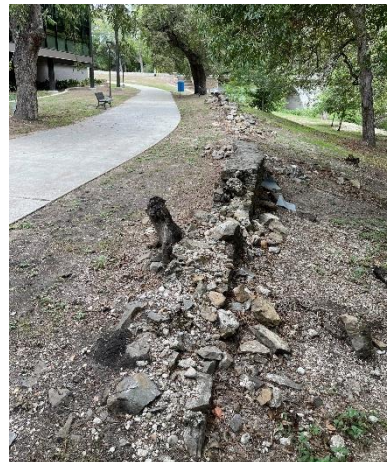
28) West Bank – failed historic stone walls along trail

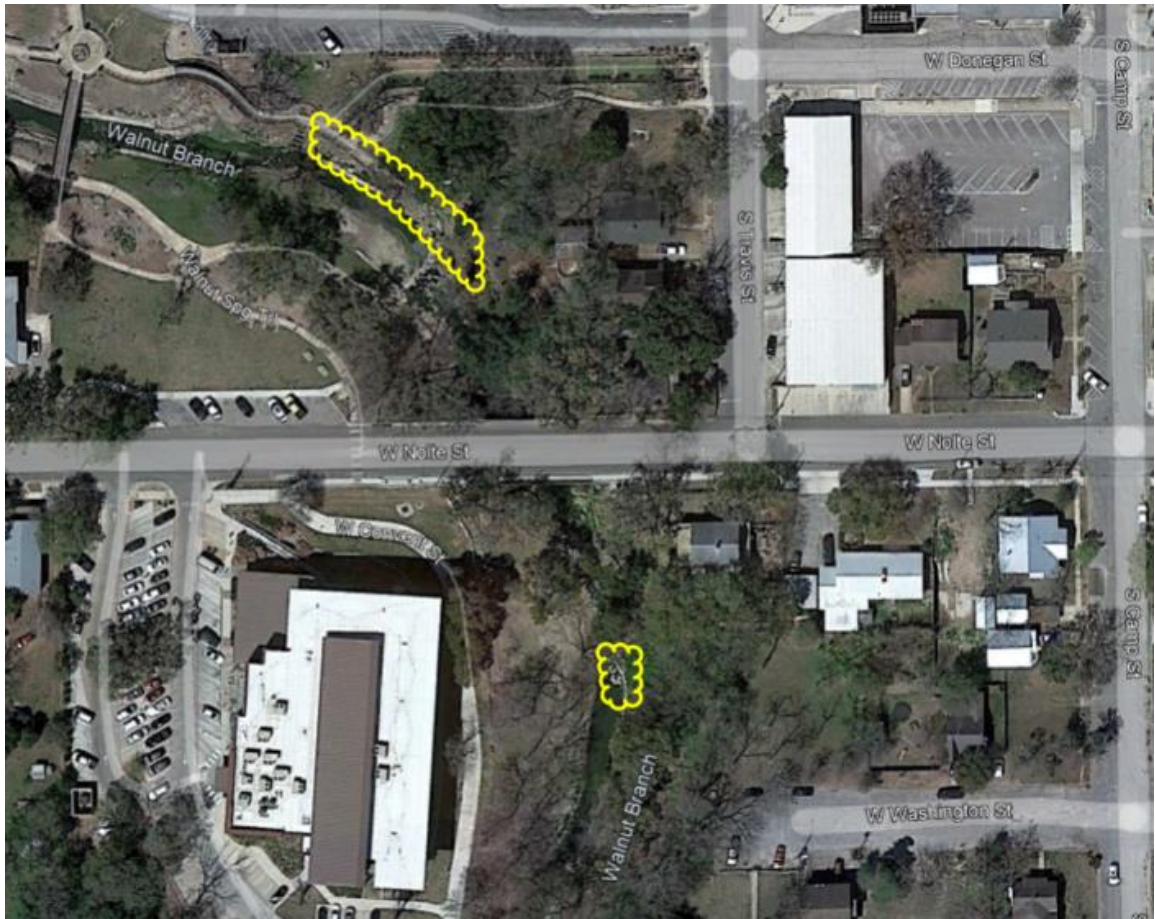
**Figure 2. Areas of greatest creek bank/wall damage based on visual observation only**

Additional investigation and evaluations will be performed in Phase 2 of the study, but based on preliminary visual observations, additional wall and embankment failure is likely to occur. While the severity of risk and likelihood of additional failure cannot be determined based on a visual inspection alone, Figure 2 illustrates two areas where the most damage and erosion were observed. The City has placed signs throughout Sites 1 and 2 warning the public of potential safety concerns due to unstable materials, erosion, and slip, trip and fall risks.
