**CITY OF SEGUIN MAIN STREET PROGRAM  
"FIX IT" GRANT APPLICATION**

Project Address: 104 N. Austin St., Seguin, TX 78155

Re: Structural Investigation #15195-0  
**104 North Austin Street**  
Seguin, Texas 78155

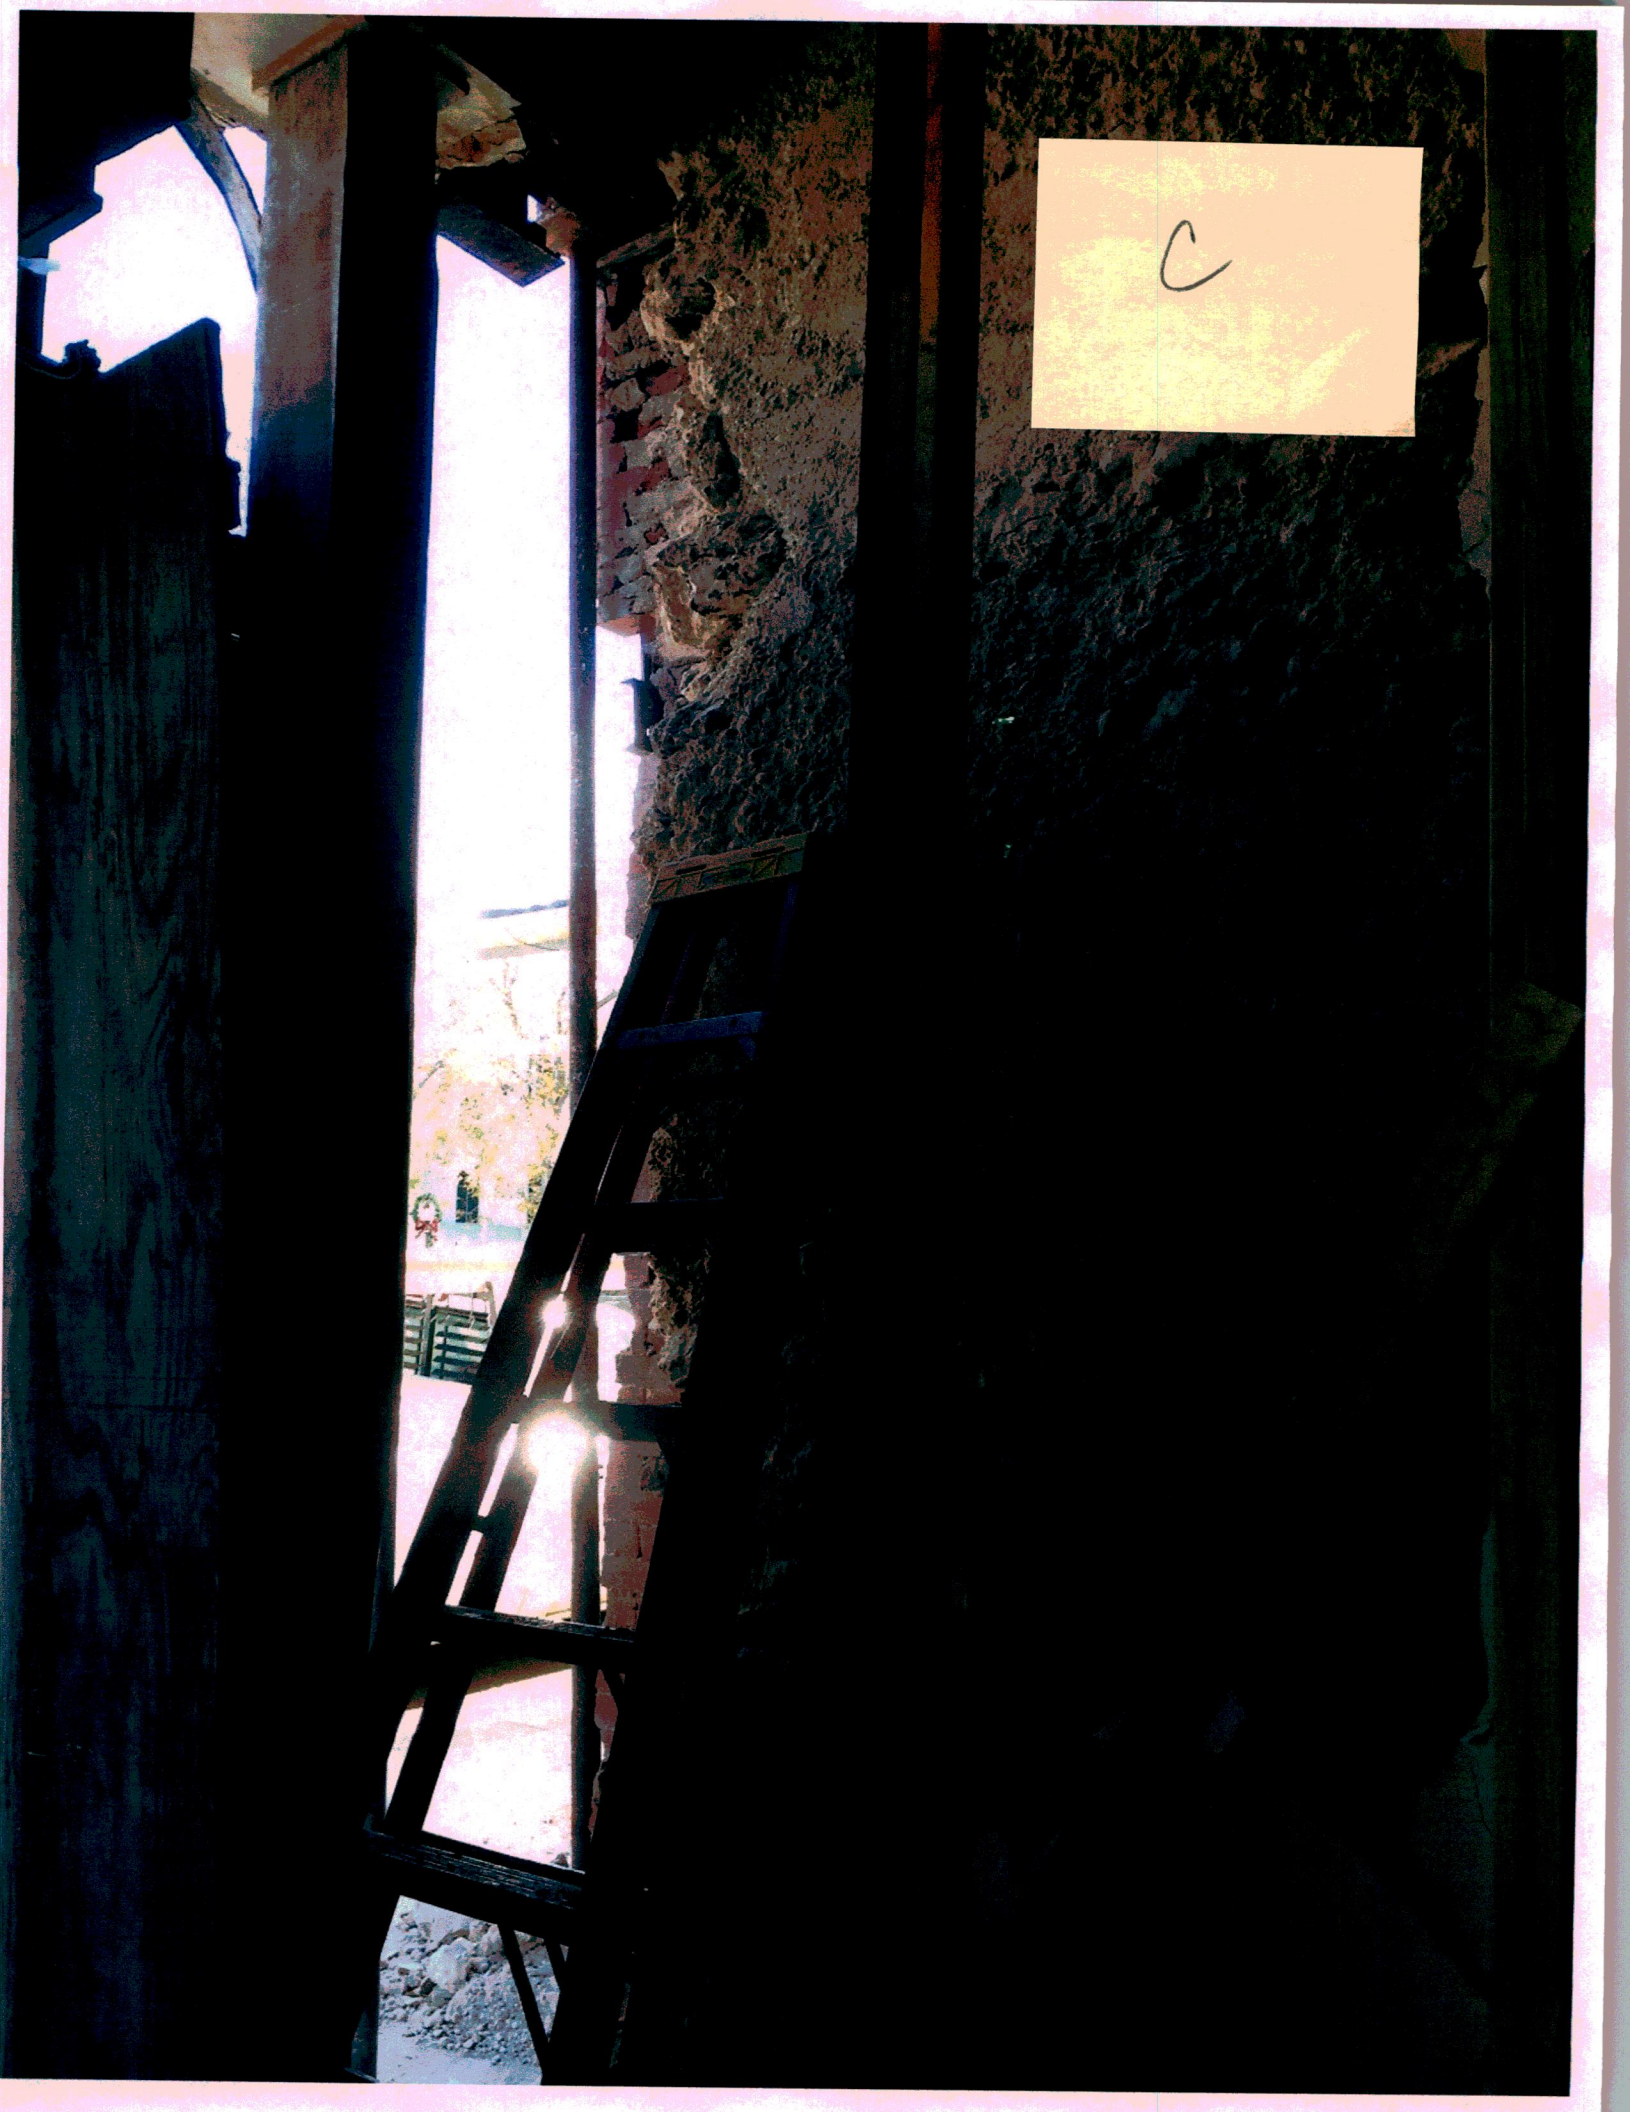
C

The front corner of this wall is built with a load bearing brick column that currently supports a steel beam that spans across the front wall and supports the top section of the wall above the storefront. This brick column is cracked vertically apart and is no longer structurally sound.

We also recommend removing the brick column at the front corner of the building and replace it with a new 4" x 4" x 1/4" HSS steel tube column directly below the steel beam above. The column should have 1/2" steel base and cap plates welded to the two steel beams above and bolted to a new concrete footing below with 4 1/2" diameter wedge anchors. The footing should be at least 3' x 3' x 3' reinforced with 4- #5 bars each way 3" from the bottom of the footing. The steel beams require proper shoring while the column is removed.
