# Walnut Springs Spillway Repair and Bank Stabilization Study

## Project Update

7/2/2024

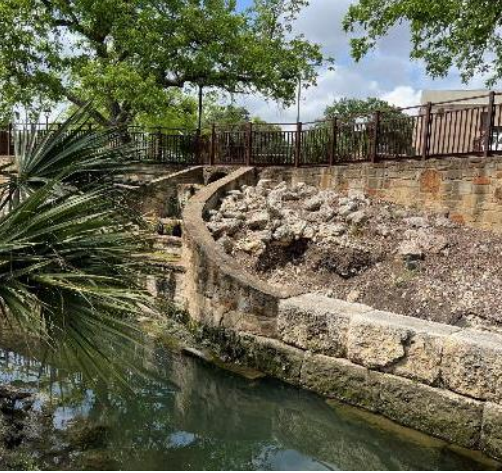
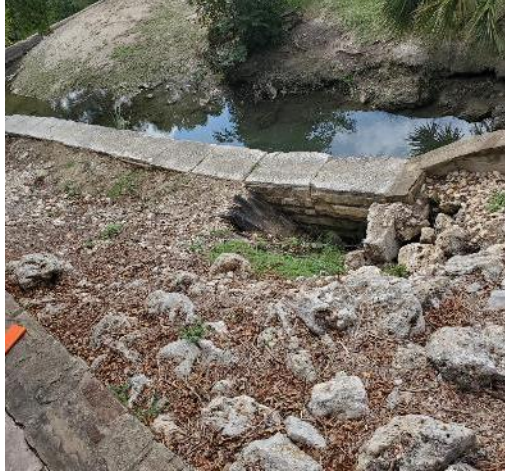
## Site 1 – North of Nolte

- Minor erosion on west bank
- Most erosion damage and bank failure on east bank
- Concrete spillway flanked by bank erosion and crest damaged

- At Sites 1, additional wall and embankment failure is likely to occur causing alteration to property

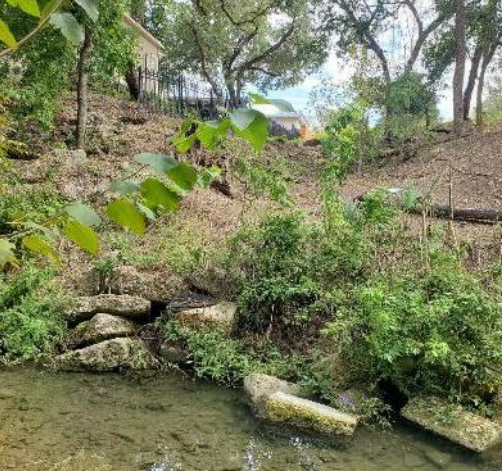
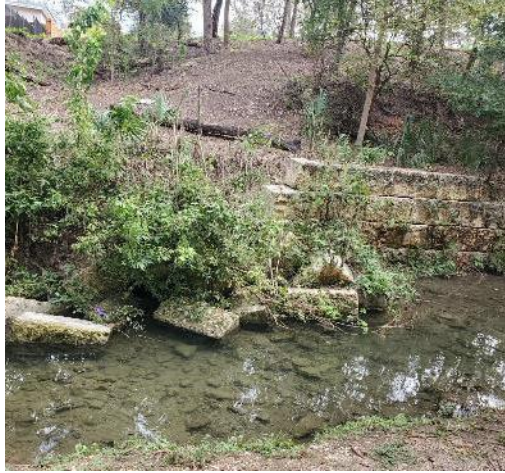
## Site 2 – South of Nolte

- Wall failure limited to upstream end
- Very minor backfill erosion at downstream end
- Remaining wall is visibly intact

- At Sites 2, additional wall and embankment failure may occur causing alteration to property

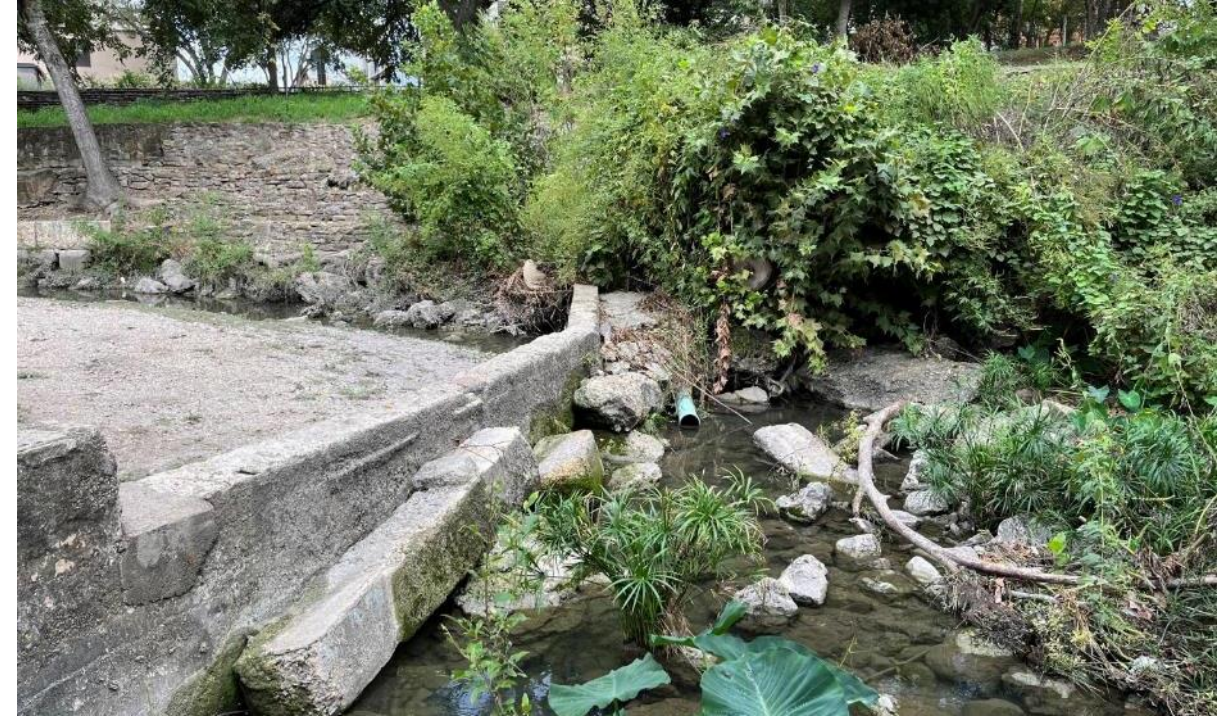
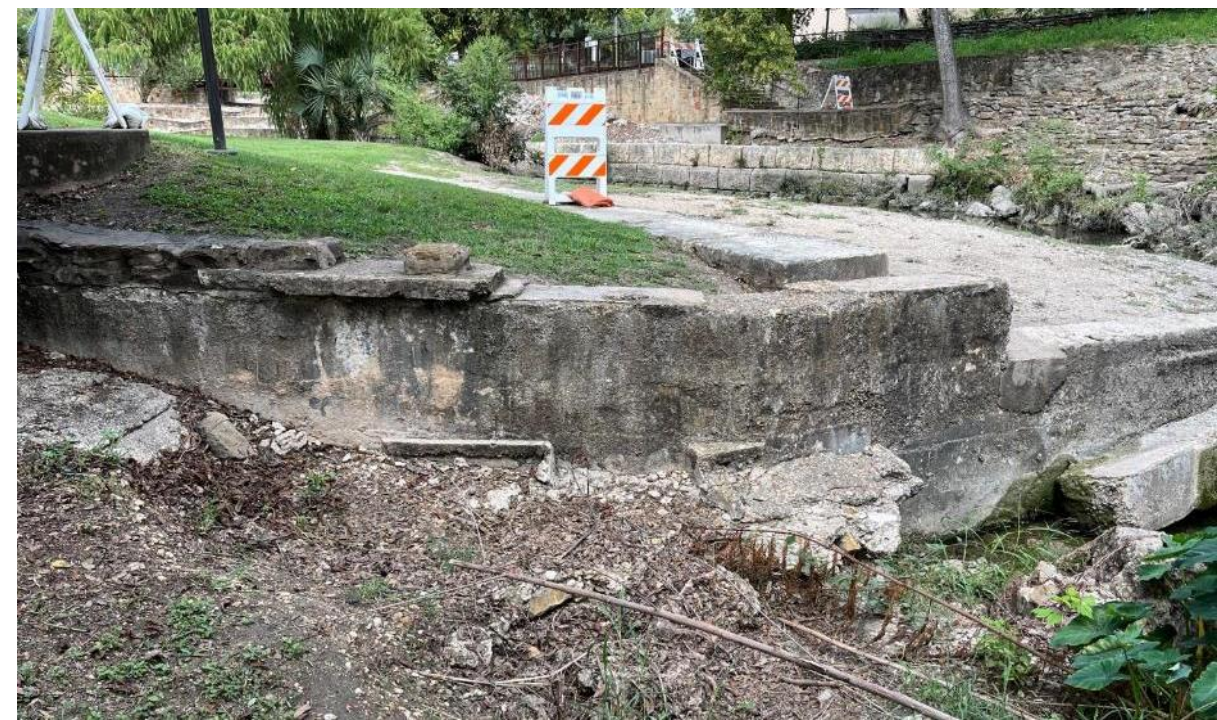
# Concrete Spillway

- Neither classified or regulated as a dam by TCEQ
- Low height and very limited impoundment
- Does not provide flood protection
- Collects sediment from upstream sources
- Provides grade control stabilizing bed of channel for upstream segment
- Largest risk for spillway is continued flanking and erosion of unprotected east bank

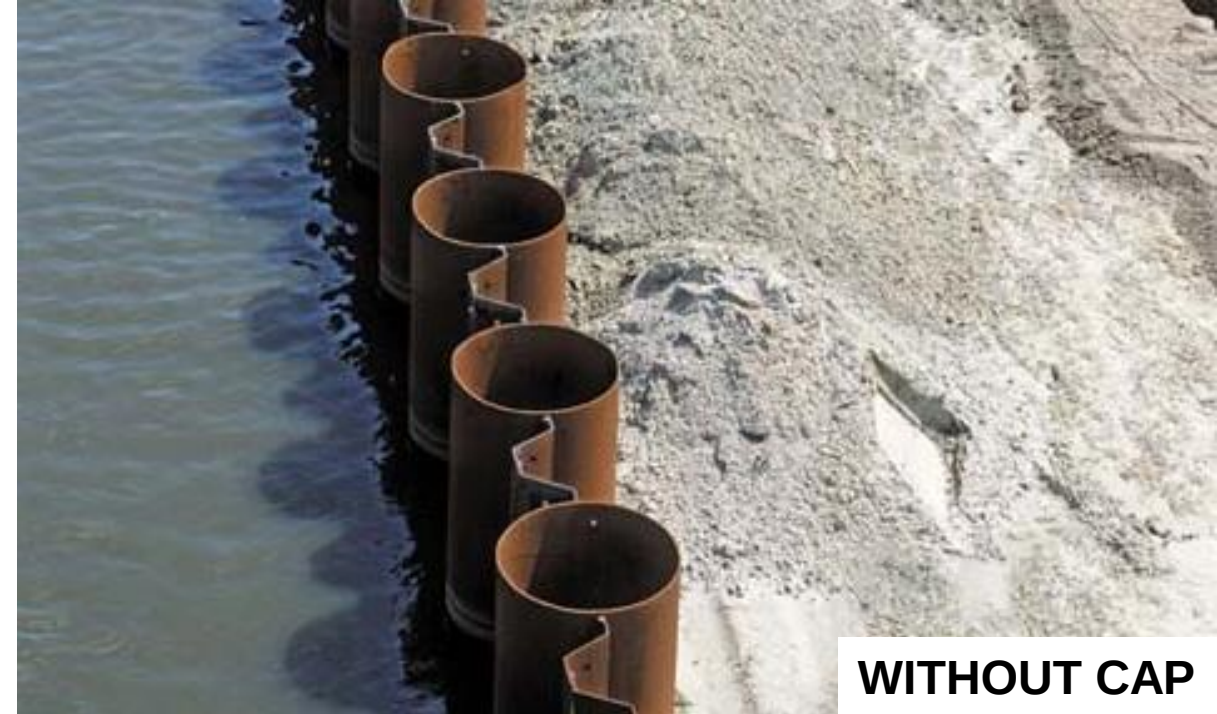
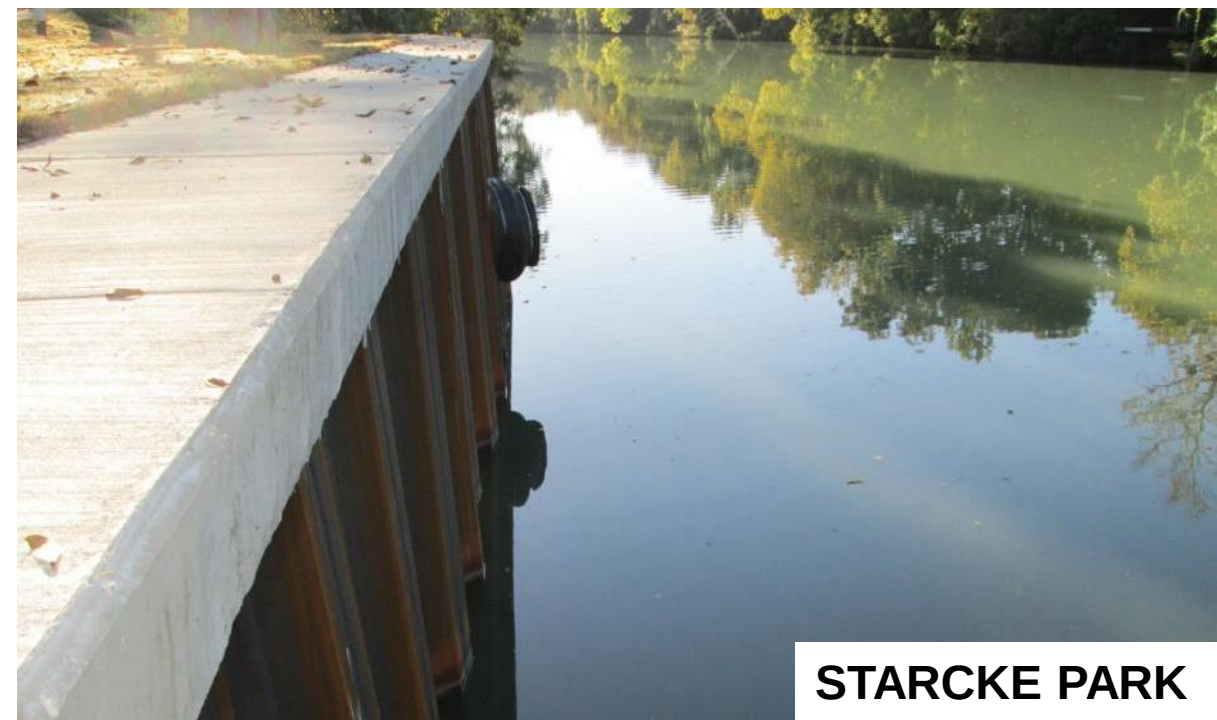
# Combi Wall System

- Deep foundation system required to improve design standard
- Combination of driven steel sheet pile and circular king piles
- Minimum 10ft of embedment into higher strength soil recommended
- Provide concrete cap (similar to Max Starcke Park)
- Protect backfill with stone riprap
