## CITY OF SEGUIN

**To:** City Council  
**From:** Melissa Reynolds, PE, MPA, CFM  
Assistant City Manager | City Engineer  
**Date:** July 21, 2026  
**Subject:** Presentation and possible direction for staff for  
Walnut Springs Bank Stabilization Design  
Alternatives

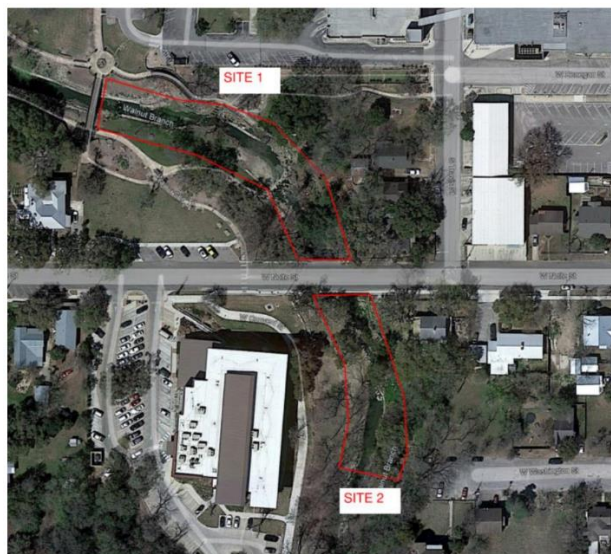
Figure 1: Walnut Branch Linear Park (Site 1) and USACE Walnut Branch Ecosystem Restoration Project (Site 2)

Site 1 and Site 2 require structural bank stabilization, as noted in the PER.

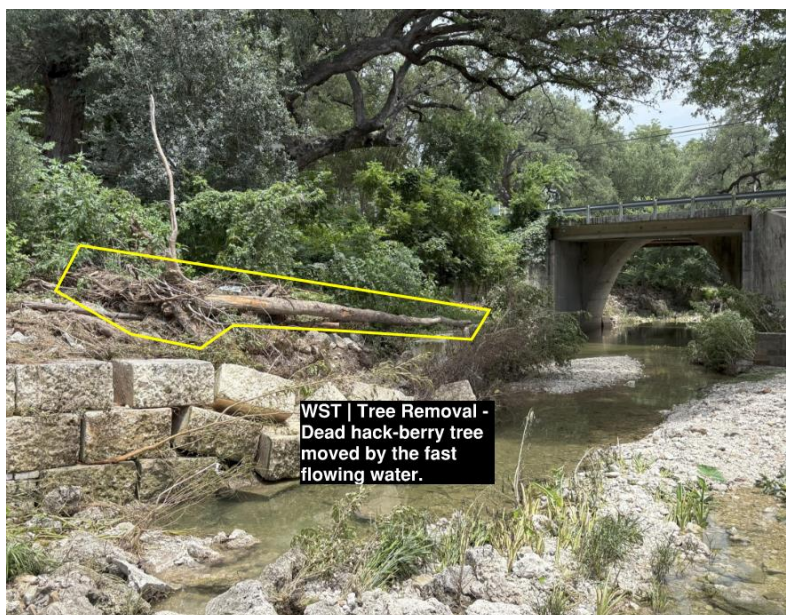
*Figure 2: Damage due to July 5, 2025 flood event*

Based on direction provided by City Council and the City's procurement policies (AF-2025-49), a Professional Services Agreement was executed with HDR Engineering, Inc. on August 5, 2025 for the engineering and permitting services required for the Walnut Springs Channel Stabilization Project. Additionally, the July 5, 2025 flood event introduced new failures to Walnut Branch.

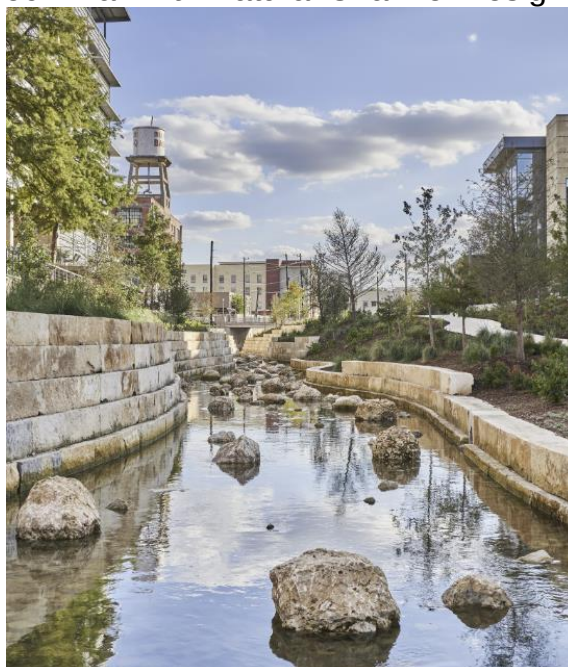
*Figure 3: Limestone Block Wall Example*

#### Option 1: Limestone Block Wall with Natural Channel Design

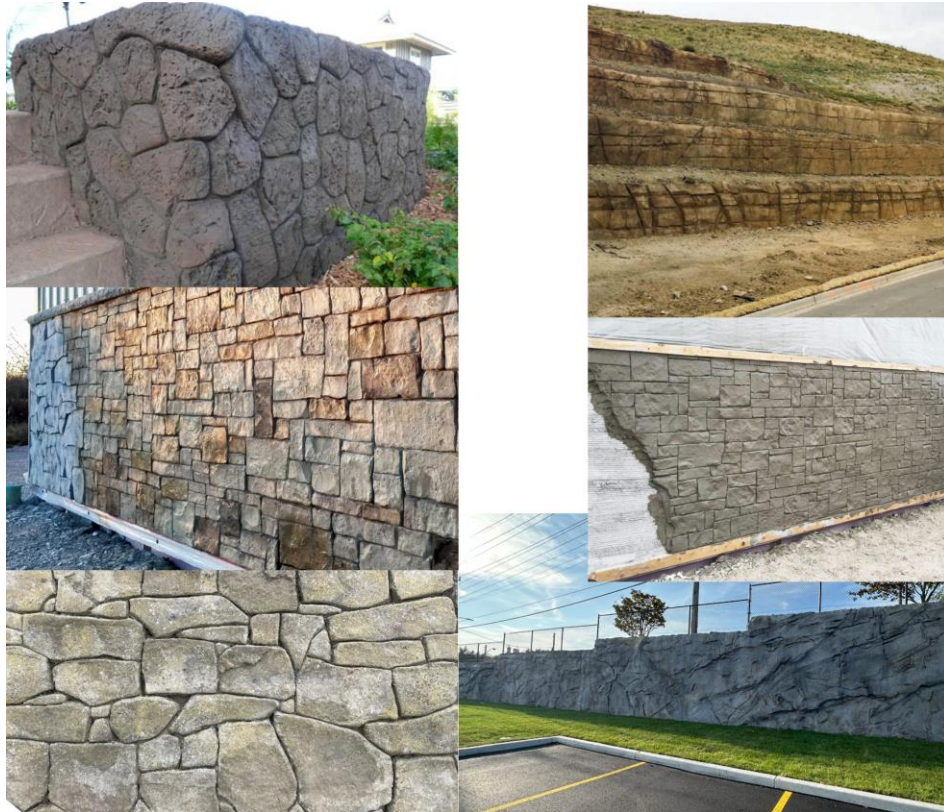
Figure 4: Reinforced Concrete Wall Examples

## Option 2: Reinforced Concrete Retaining Wall with Finishings with Natural Channel Design
