# Current Status of Meadow Lake Dam Repairs

# Technical Memorandum

**Gravity Stability Analysis Report  
Nolte Dam Modifications**  
Meadow Lake, Texas

# MEADOW LAKE SPILLWAY MODIFICATIONS

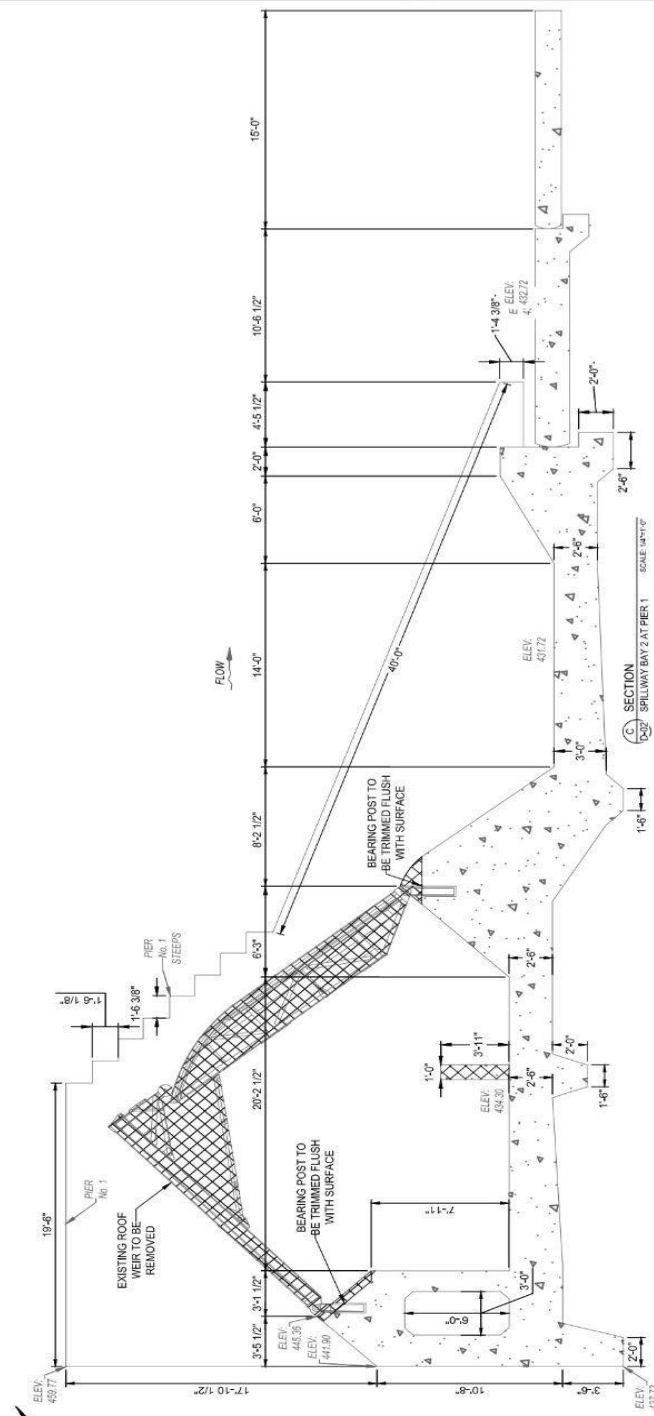
Attention: 1" = 1' If this scale has not been indicated, check for the 1" then drawing is not original scale.	<b>DRAFT</b>	Designer: IMG Drawn: YMS Checked: CK Approved: ##### P.E. No.: ## GEI Project: 2405235	<p>GEI CONSULTANTS 6600 W. BRIDGES BLVD. SUITE 150 DALLAS, TEXAS 75244 PH: 972.522.5200</p>	MEADOW LAKE WATER CONTROL AND IMPROVEMENTS DISTRICT 1 4301 BULL CREEK ROAD, SUITE 150 AUSTIN, TEXAS 78731	<b>MEADOW LAKE/NOLTE DAM MODIFICATIONS</b>  <b>SEGUN, TX</b>	SHEET NAME <b>DEMOLITION SPILLWAY TRANSVERSE SECTIONS (SHEET 2 OF 2)</b>	SHEET NO. <b>D-06</b>
		NO. DATE 0 8/15/2025

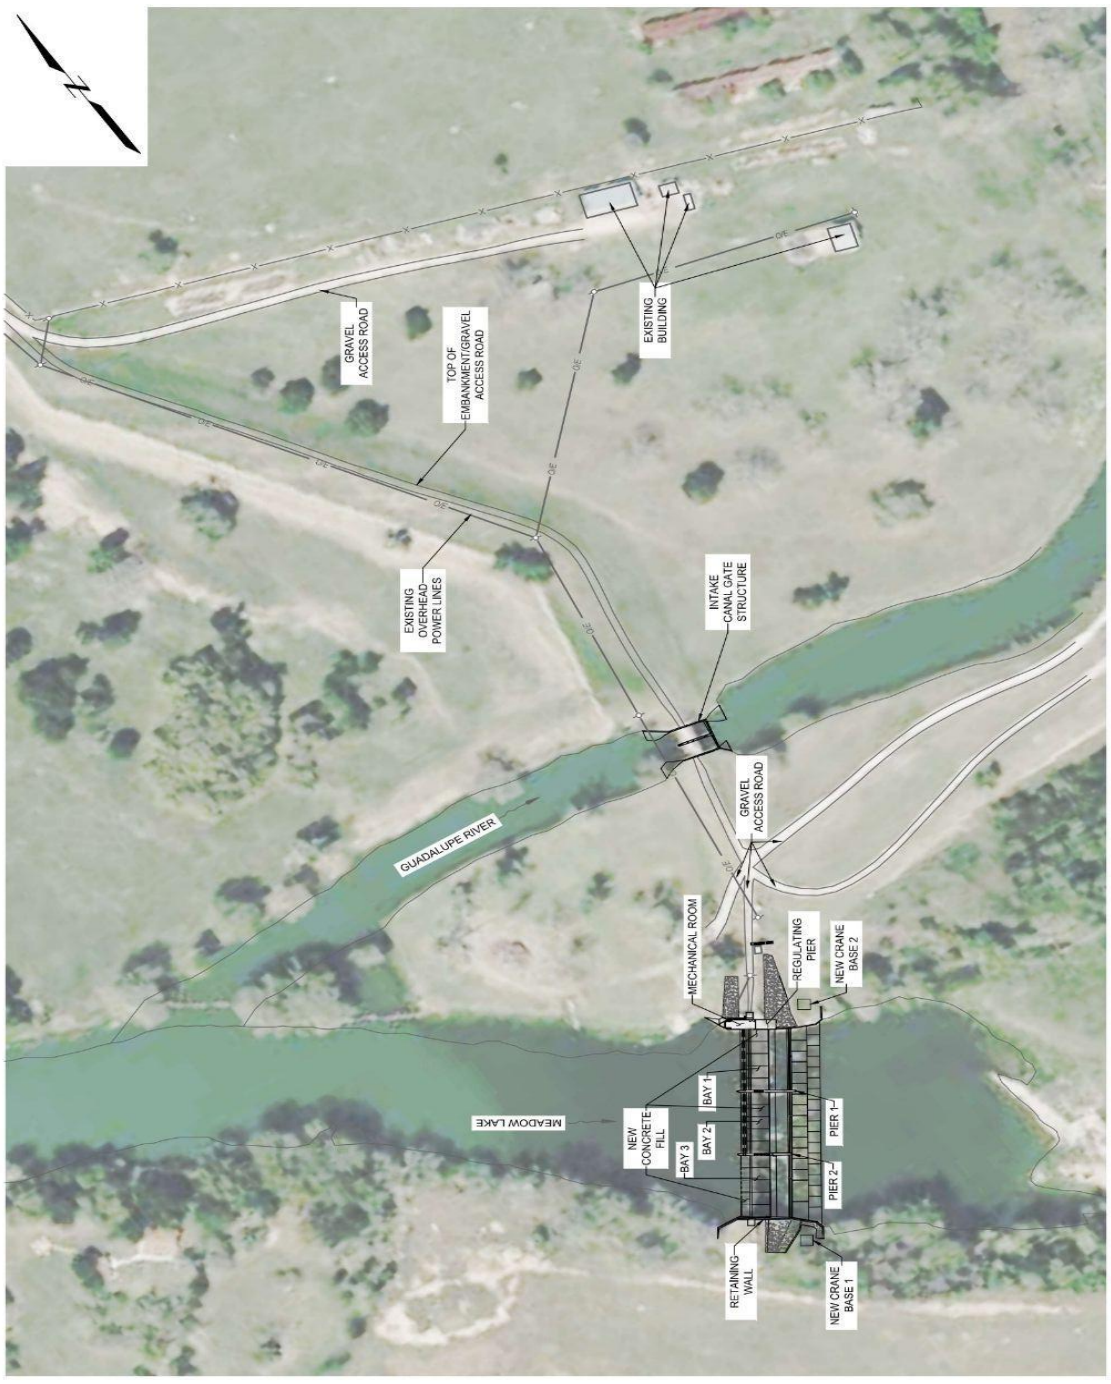
<b>DRAFT</b>	Designator: MG Drawer: YMS Checker: CK Approver: ##### P.E. No: ## GEI Project: 2465255	  <b>MEADOW LAKE WATER CONTROL AND IMPROVEMENTS DISTRICT 1</b> 4301 BULL CREEK ROAD, SUITE 150 AUSTIN, TEXAS 78731	<b>MEADOW LAKE/NOLTE DAM MODIFICATIONS</b>  <b>SEGUN, TX</b>	SHEET NAME <b>STRUCTURAL MODIFICATIONS SITE PLAN</b>	SHEET NO. <b>S-01</b>
	Attention: 1" If the scale bar does not match the drawing, the drawing is not original scale.	NO DATE 0 8/15/2025 60% SUBMITTAL ISSUE/REVISION CTK APP	MEADOW LAKE WATER CONTROL AND IMPROVEMENTS DISTRICT 1 4301 BULL CREEK ROAD, SUITE 150 AUSTIN, TEXAS 78731 GEI Consultants 5000 W. BRIDGES BLVD., SUITE 100 FORT WORTH, TEXAS 76102-0100 (817) 332-6200

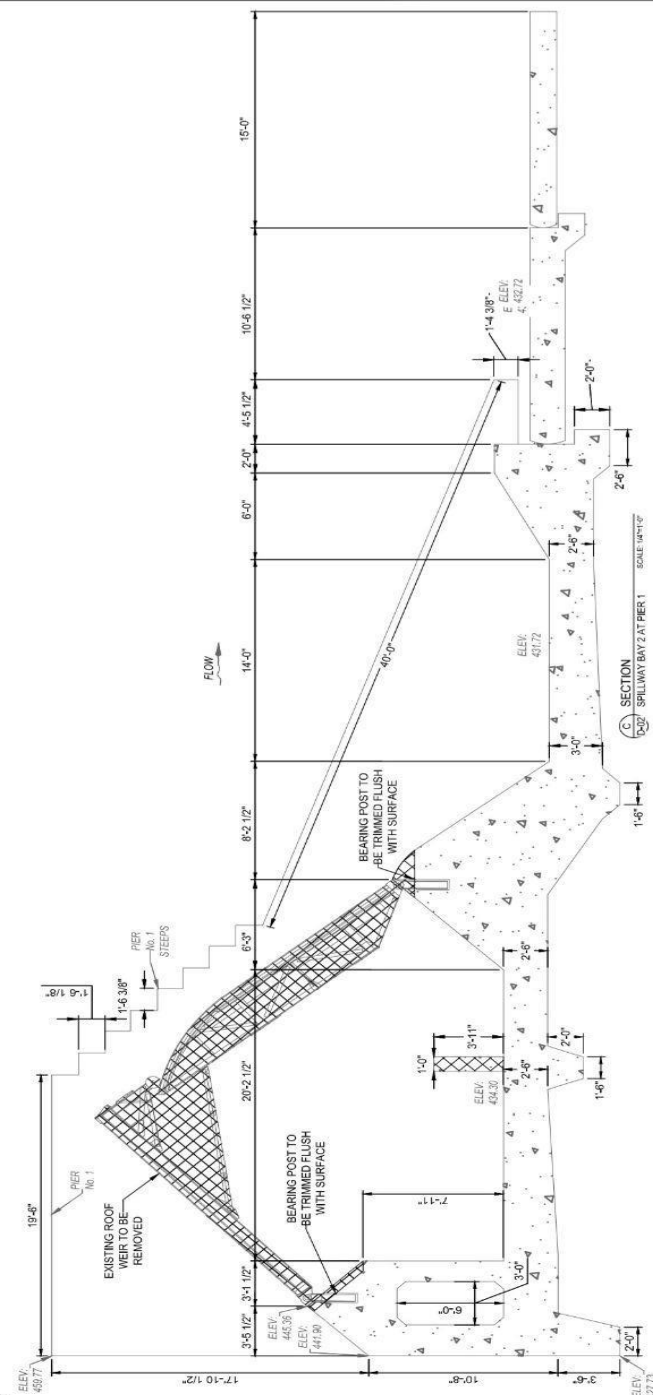
DESIGNED: MG	DRAWN: YMS	CHECKED: CK	APPROVED: #####	P.E. NO: ##	GEI Project: 2405255
MEADOW LAKE WATER CONTROL AND IMPROVEMENTS DISTRICT 1 4301 BULL CREEK ROAD, SUITE 150 AUSTIN, TEXAS 78731	<p><b>MEADOW LAKE/NOLTE DAM MODIFICATIONS SEGUIN, TX</b></p>				
SHEET NAME		SHEET NO.		D-06	
DEMOLITION SPILLWAY TRANSVERSE SECTIONS (SHEET 2 OF 2)		ISSUE/REVISION		CTK APP	
NO	DATE	ISSUE/REVISION	CTK	APP	
0	8/15/2025	60% SUBMITTAL	CTK	APP
