Tree Removal Plan

Trees Scheduled For Removal For Safety, Lake Construction, And Green Or Tee Construction.

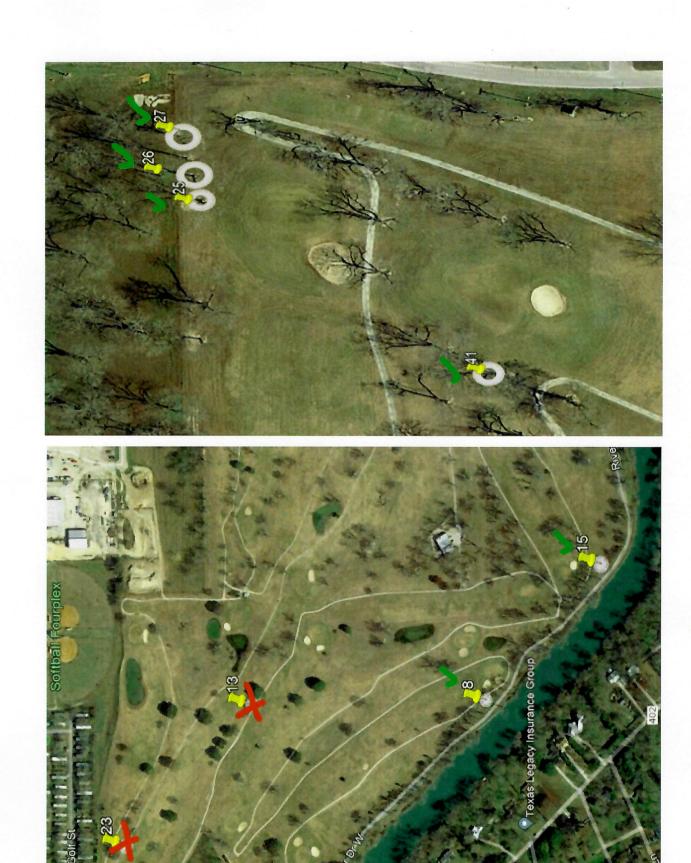
Review Of Trees Scheduled For Removal For Playability Reasons
