# Walnut Springs Spillway and Bank Stabilization Repair

Project Planning Memorandum

*Seguin, Texas*  
June 6, 2024

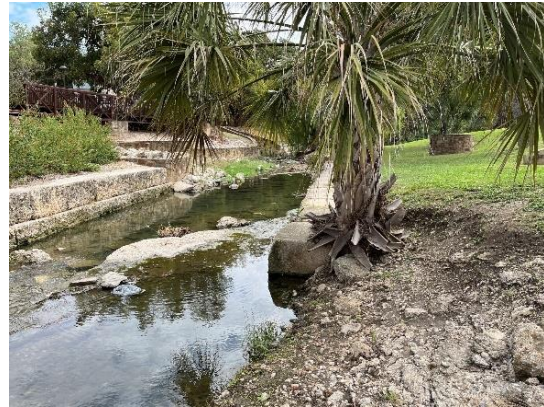
2) West Bank – Flanking by erosion

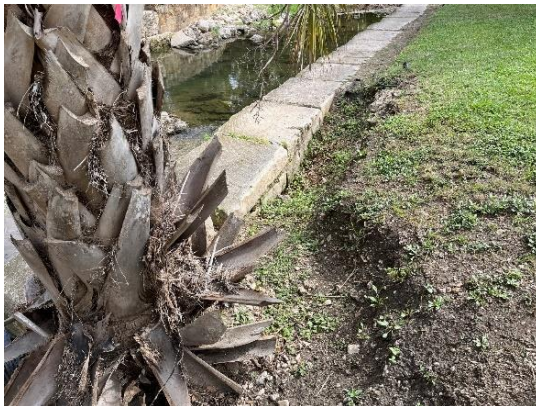
3) West Bank – Erosion behind toe wall

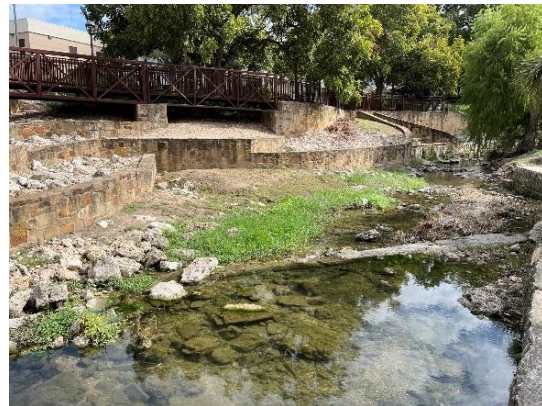
4) East Bank – Sedimentation and existing utility

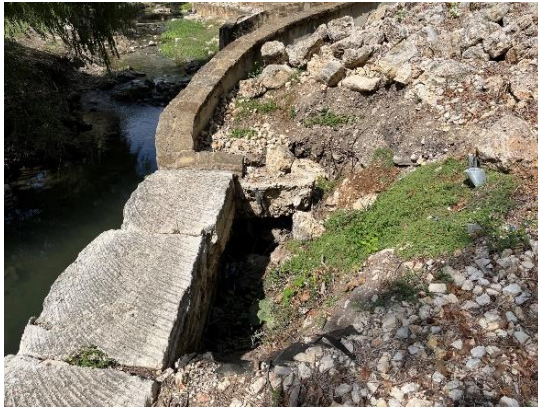
9) East Bank – Loss of backfill behind wall

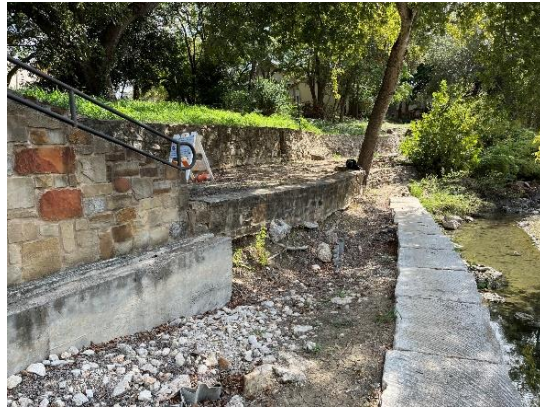
10) East Bank – overbank scour

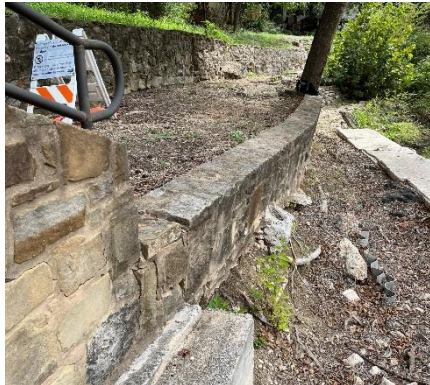
11) East Bank – leaning wall and overbank scour

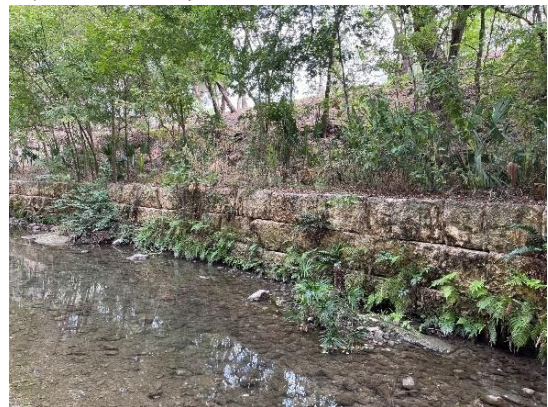
22) East Bank – intact wall

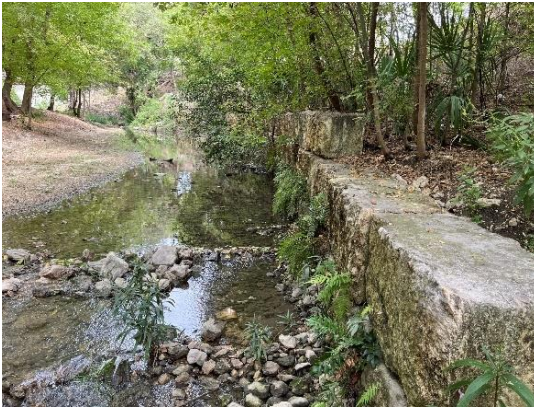
23) East Bank – Looking upstream at downstream terminus

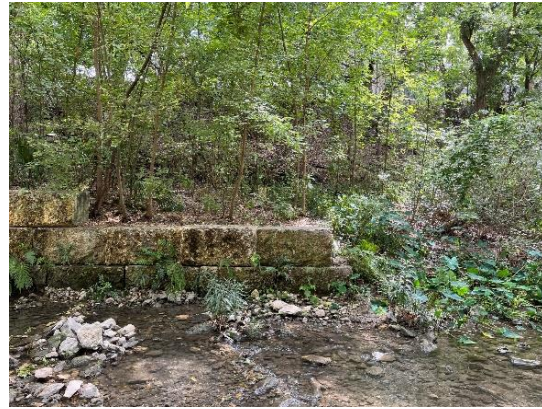
24) East Bank – downstream terminus

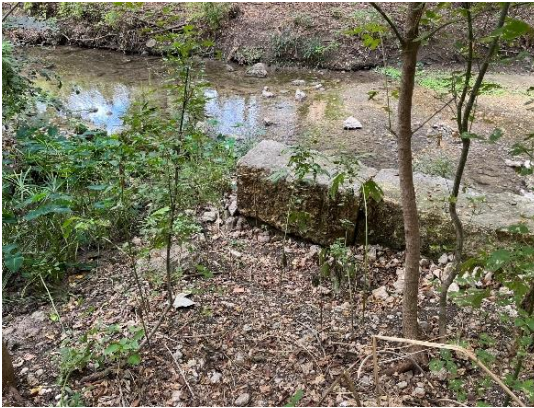
25) East Bank – downstream terminus, minor erosion

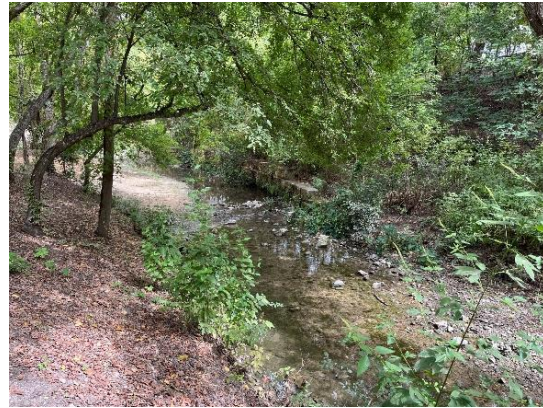
26) Looking upstream from downstream of east bank wall

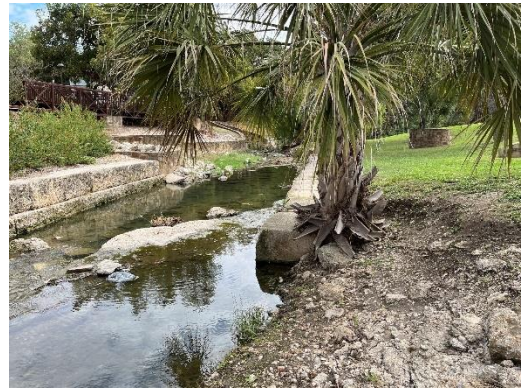
2) West Bank – Flanking by erosion

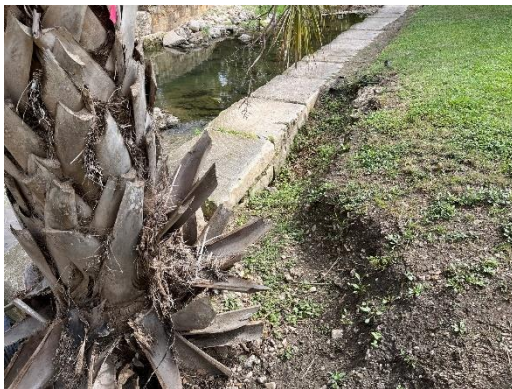
3) West Bank – Erosion behind toe wall

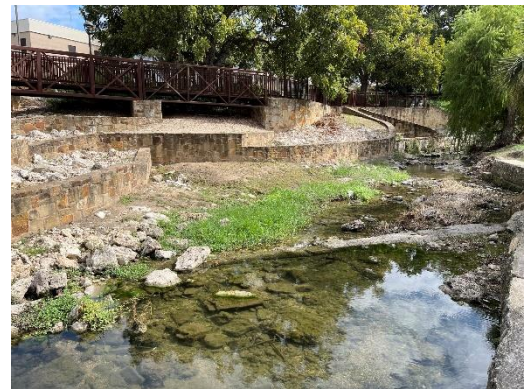
4) East Bank – Sedimentation and existing utility

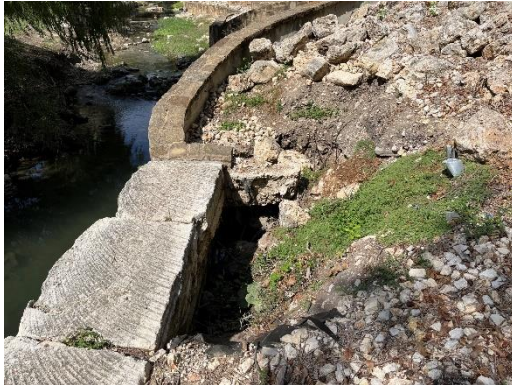
9) East Bank – Loss of backfill behind wall

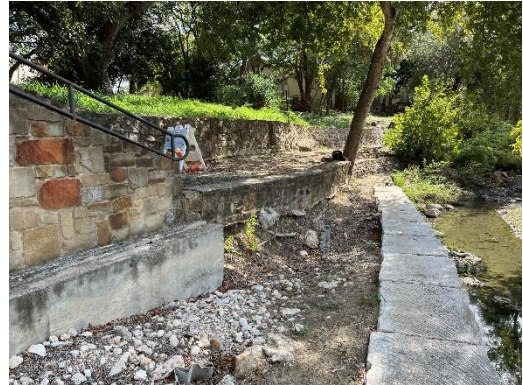
10) East Bank – overbank scour

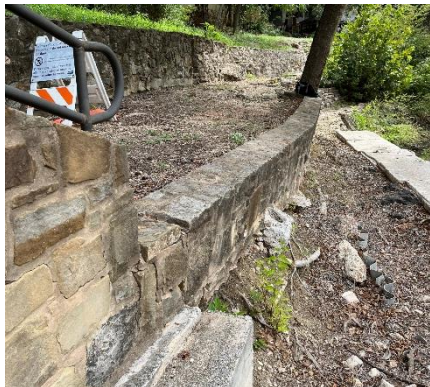
11) East Bank – leaning wall and overbank scour

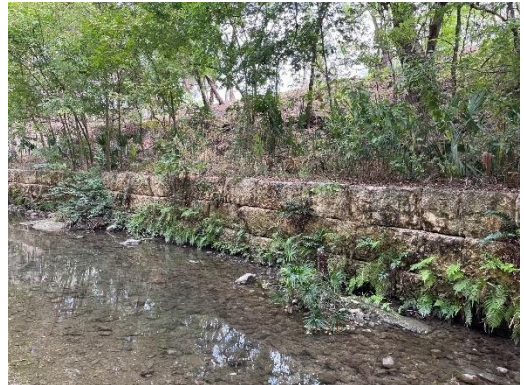
22) East Bank – intact wall

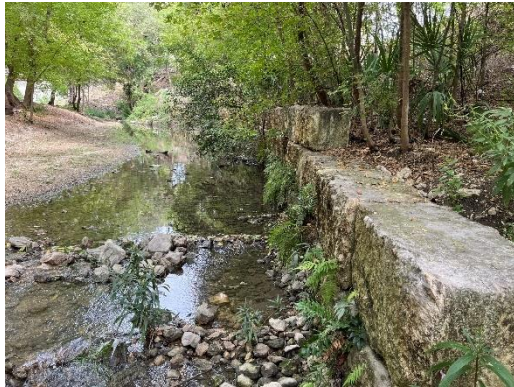
23) East Bank - Looking upstream at downstream terminus of 2016 wall

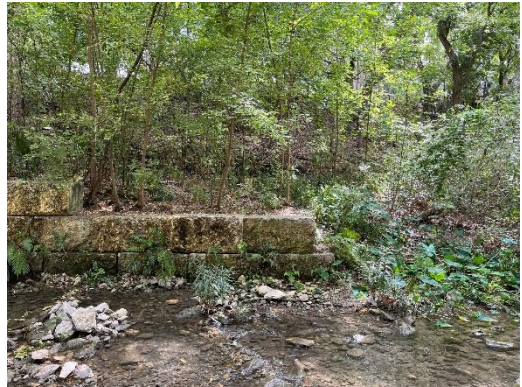
24) East Bank – downstream terminus of 2016 wall

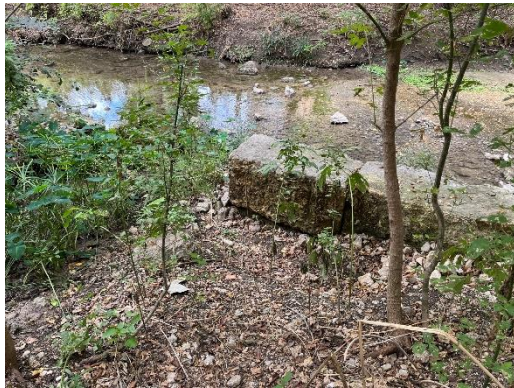
25) East Bank – downstream terminus of 2016 wall

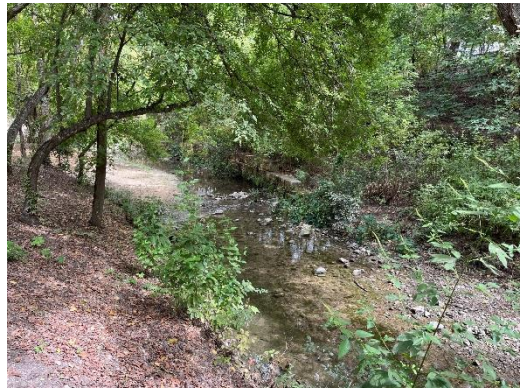
26) Looking upstream from downstream of east bank wall
